# Access Compliance Report Public Rights-of-Way (Curb Ramps)

| Main Street: MONTECITO_RD | | Cross Street: COPA_DE_ORO_DR | | Location: | SE |
| ADA ID: RPRK211209111246 | Ramp Type:Type 1 - Perpendicular | Initial Pass/Fail: Fail | Overall Compliance: No | Severity Score: | 30 |

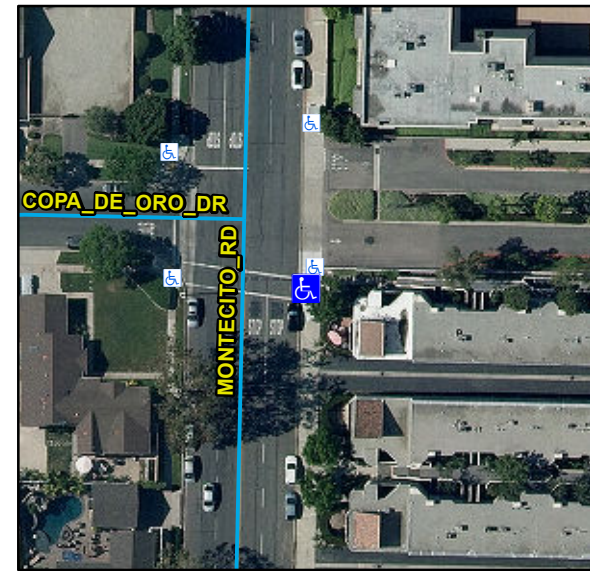
**R304.2.2, STD 1115**

| Compliance | Description | Data | Compliance | Description | Data |
|---|---|---|---|---|---|
| <b>No</b> | Ramp Run Slope (%) | <b>12.2</b> | <b>N/A</b> | Flare Slope LT (%) | <b>N/A</b> |

**Remove & Replace Entire Ramp. Restripe Crosswalk.**
