# Access Compliance Report Public Rights-of-Way (Curb Ramps)

| Main Street: COPA_DE_ORO_DR | | Cross Street: MONTECITO_RD | | Location: | SE |
| ADA ID: RPRK211209111426 | Ramp Type:Type 1 - Perpendicular | Initial Pass/Fail: Fail | Overall Compliance: No | Severity Score: | 2 |

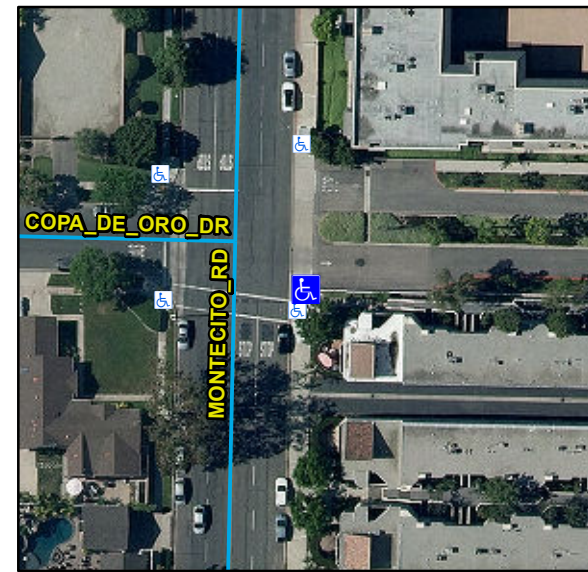
R304.5.3, STD 1115

| Compliance | Description | Data | Compliance | Description | Data |
|---|---|---|---|---|---|
| No | Ramp Cross Slope (%) | 4.2 | N/A | Flare Traversable LT | N/A |

Remove & Replace Entire Ramp.

Total Cost: \$ 3080
