# Access Compliance Report Public Rights-of-Way (Curb Ramps)

Main Street: BLUME\_DR Cross Street: BALLANTINE\_DR Location: SE

ADA ID: RPRK211209115249 Ramp Type: Type 1 - Perpendicular Diagonal Initial Pass/Fail: Fail Overall Compliance: No Severity Score: 2

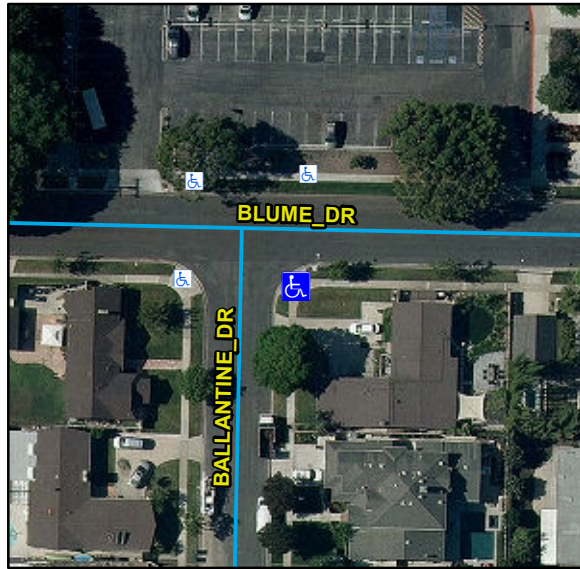
| Compliance | Description | Data | Compliance | Description | Data |
|---|---|---|---|---|---|
| No | Ramp Cross Slope (%) | 2.7 | N/A | Flare Traversable LT | N/A |

Remove & Replace Curb Ramp With Two New Directional Ramps or Equivalent.

R204.3, R304.5.3, STD 1115
