# Access Compliance Report Public Rights-of-Way (Curb Ramps)

Main Street: TUCKER\_LN Cross Street: FOSTER\_RD Location: SE

ADA ID: RPRK211209122955 Ramp Type: Type 1 - Perpendicular Diagonal Initial Pass/Fail: Fail Overall Compliance: No Severity Score: 2

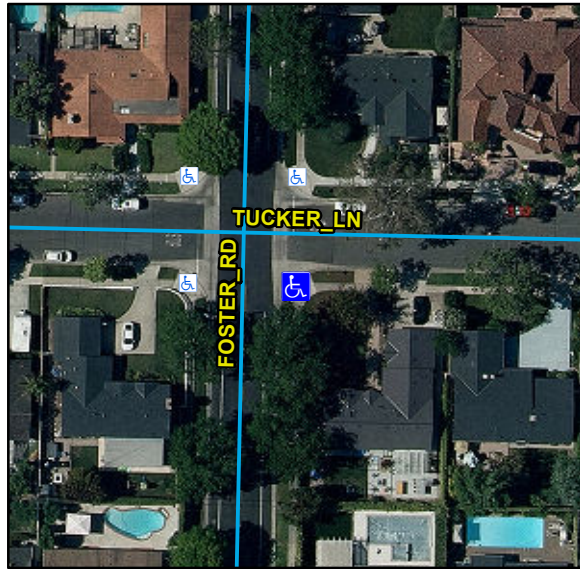
| Compliance | Description | Data | Compliance | Description | Data |
|---|---|---|---|---|---|
| No | Ramp Cross Slope (%) | 2.1 | N/A | Flare Traversable LT | N/A |

**Remove & Replace Curb Ramp With Two New Directional Ramps or Equivalent.**

**R204.3, R304.5.3, STD 1115**
