# Access Compliance Report Public Rights-of-Way (Curb Ramps)

Main Street: HARRISBURG\_RD Cross Street: WALLINGSFORD\_RD Location: NW

ADA ID: RPRK211215120109 Ramp Type: Type 1 - Perpendicular Diagonal Initial Pass/Fail: Fail Overall Compliance: No Severity Score: 16

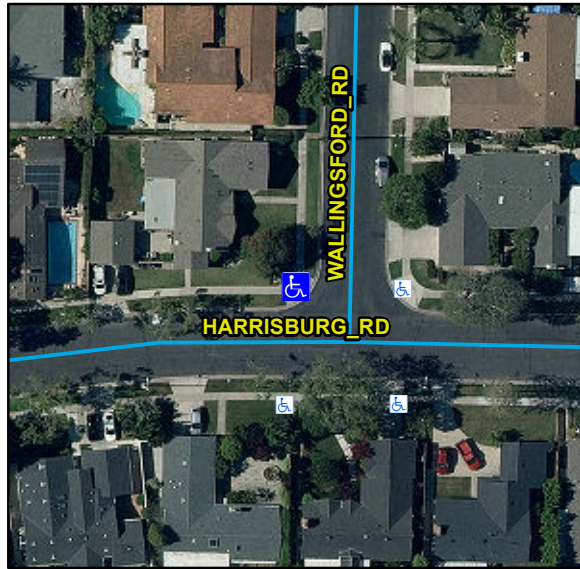
| Compliance | Description | Data | Compliance | Description | Data |
|---|---|---|---|---|---|
| No | Ramp Run Slope (%) | 9.5 | N/A | Flare Slope LT (%) | N/A |
| No | Ramp Cross Slope (%) | 2.1 | N/A | Flare Traversable LT | N/A |

Remove & Replace Curb Ramp With Two New Directional Ramps or Equivalent.
