# Access Compliance Report Public Rights-of-Way (Curb Ramps)

Main Street: PEMBERTON\_RD Cross Street: HARRISBURG\_RD Location: NE

ADA ID: RPRK211215120511 Ramp Type: Type 1 - Perpendicular Diagonal Initial Pass/Fail: Fail Overall Compliance: No Severity Score: 16

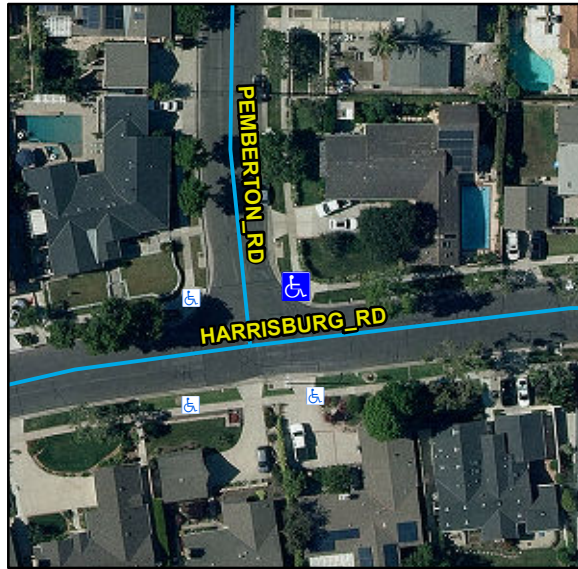
| Compliance | Description | Data | Compliance | Description | Data |
|---|---|---|---|---|---|
| No | Ramp Run Slope (%) | 9 | N/A | Flare Slope LT (%) | N/A |

Remove & Replace Curb Ramp With Two New Directional Ramps or Equivalent.
