# Access Compliance Report Public Rights-of-Way (Curb Ramps)

Main Street: FOSTER\_RD Cross Street: GERTRUDE\_DR Location: SW

ADA ID: RPRK211216123818 Ramp Type: Type 1 - Perpendicular Diagonal Initial Pass/Fail: Fail Overall Compliance: No Severity Score: 15

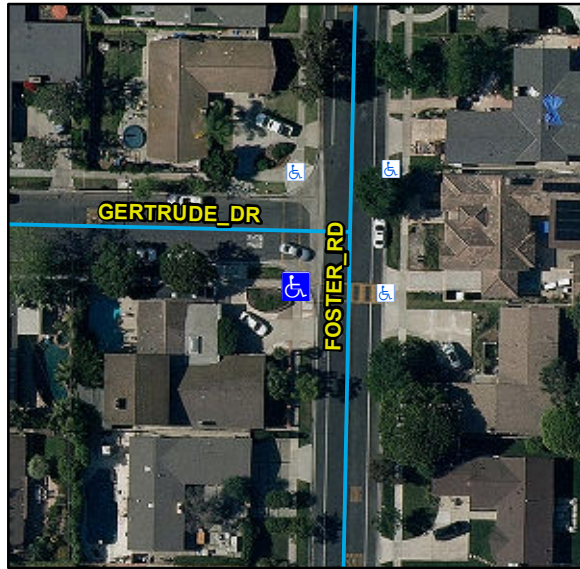
| Compliance | Description | Data | Compliance | Description | Data |
|---|---|---|---|---|---|
| No | Ramp Run Slope (%) | 9.1 | N/A | Flare Slope LT (%) | N/A |

Remove & Replace Curb Ramp With Two New Directional Ramps or Equivalent.

R204.3, R304.2.2, STD 1115
