# Access Compliance Report Public Rights-of-Way (Curb Ramps)

Main Street: WEATHERBY\_RD Cross Street: CORTESE\_DR Location: NE

ADA ID: RPRK211217132440 Ramp Type: Type 4 - Parallel Initial Pass/Fail: Fail Overall Compliance: No Severity Score: 2

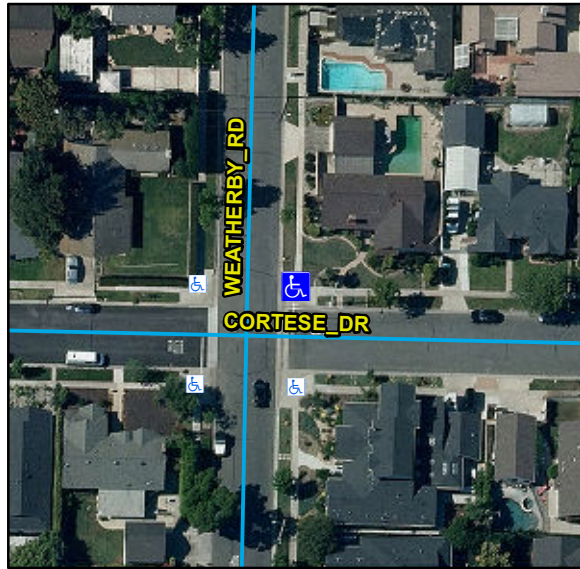
| Compliance | Description | Data | Compliance | Description | Data |
|---|---|---|---|---|---|
| Yes | Ramp Cross Slope LT (%) | 1.9 | No | Ramp Cross Slope RT (%) | 2.7 |

**Remove & Replace Curb Ramp With Two New Directional Ramps or Equivalent.**

**R304.5.3, STD 1115**
