# Access Compliance Report Public Rights-of-Way (Curb Ramps)

Main Street: SANTIAGO\_CANYON\_RD Cross Street: N\_LINDA\_VISTA\_ST Location: SE

ADA ID: RPRK211222121545 Ramp Type: Type 1 - Perpendicular Diagonal Initial Pass/Fail: Fail Overall Compliance: No Severity Score: 15

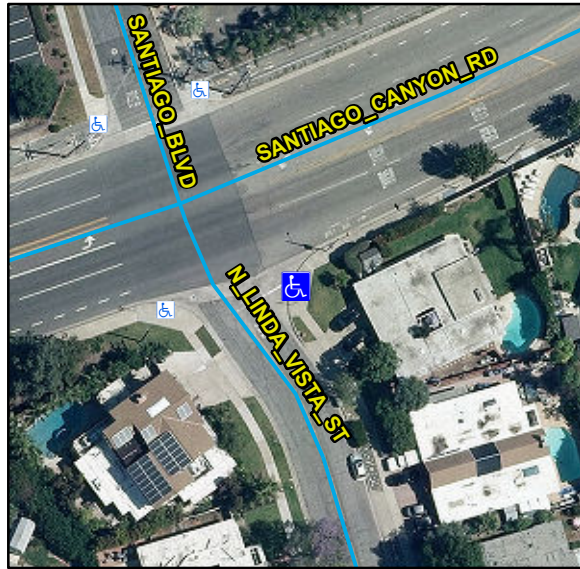
| Compliance | Description | Data | Compliance | Description | Data |
|---|---|---|---|---|---|
| No | Ramp Run Slope (%) | 10.7 | N/A | Flare Slope LT (%) | N/A |
| No | Gutter Lip Height (in) | 0.25 | | Road Run Slope (%) | 0.3 |

Remove & Replace Curb Ramp With Two New Directional Ramps or Equivalent. Grind Gutter Lip.

R204.3, R304.2.2, R302.7.2, STD 1115
