# Access Compliance Report Public Rights-of-Way (Curb Ramps)

Main Street: VILLA\_PARK\_RD Cross Street: SANTIAGO\_BLVD Location: NW

ADA ID: RPRK211222122126 Ramp Type: Blended Transition 2 Initial Pass/Fail: Fail Overall Compliance: No Severity Score: 16

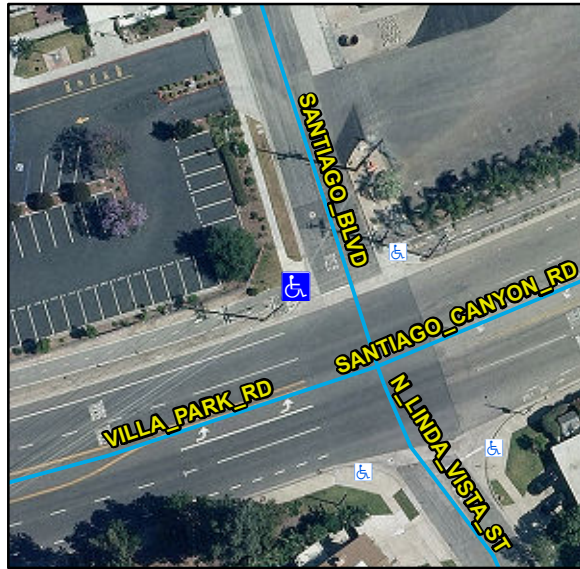
| Compliance | Description | Data | Compliance | Description | Data |
|---|---|---|---|---|---|
| No | Ramp Run Slope (%) | 10.3 | N/A | Flare Slope RT (%) | N/A |
| No | Ramp Cross Slope (%) | 2.5 | N/A | Flare Traversable RT | N/A |

Remove & Replace Curb Ramp With Two New Directional Ramps or Equivalent.

R304.2.2, R304.5.3, STD 1115
