# Access Compliance Report Public Rights-of-Way (Curb Ramps)

Main Street: SANTIAGO\_CANYON\_RD Cross Street: ORANGE\_PARK\_BLVD Location: NW

ADA ID: RPRK211222133645 Ramp Type: Type 1 - Perpendicular Initial Pass/Fail: Fail Overall Compliance: No Severity Score: 15

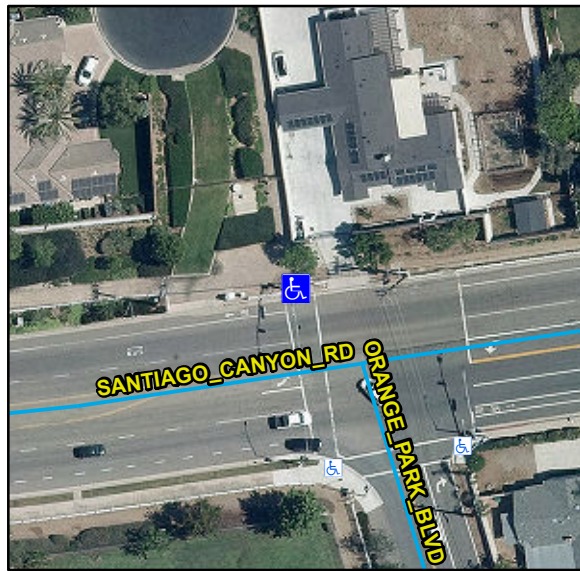
| Compliance | Description | Data | Compliance | Description | Data |
|---|---|---|---|---|---|
| No | Ramp Run Slope (%) | 10.4 | N/A | Flare Slope LT (%) | N/A |
| No | Gutter Lip Height (in) | 0.25 | | Road Run Slope (%) | N/A |

Remove & Replace Entire Ramp. Grind Gutter Lip.

R204.3, R304.2.2, R302.7.2, STD 1115
