# Access Compliance Report Public Rights-of-Way (Curb Ramps)

Main Street: HEWES\_ST Cross Street: VILLA\_PARK\_RD Location: SW

ADA ID: RPRK211222135735 Ramp Type: Type 1 - Perpendicular Diagonal Initial Pass/Fail: Fail Overall Compliance: No Severity Score: 30

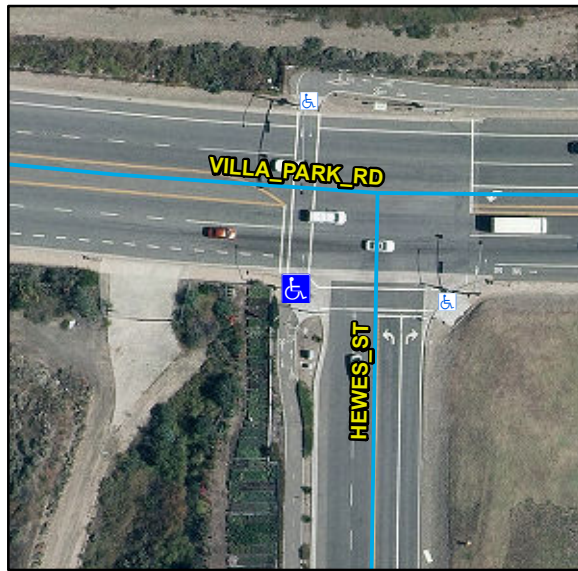
| Compliance | Description | Data | Compliance | Description | Data |
|---|---|---|---|---|---|
| No | Ramp Cross Slope (%) | 9.9 | N/A | Flare Traversable LT | N/A |

Remove & Replace Curb Ramp With Two New Directional Ramps or Equivalent.
