# Access Compliance Report Public Rights-of-Way (Curb Ramps)

| Main Street: VILLA_PARK_RD | | Cross Street: LEMON_ST | | Location: | NW |
| ADA ID: RPRK211222141925 | Ramp Type:Type 1 - Perpendicular | Initial Pass/Fail: Fail | Overall Compliance: No | Severity Score: | 15 |

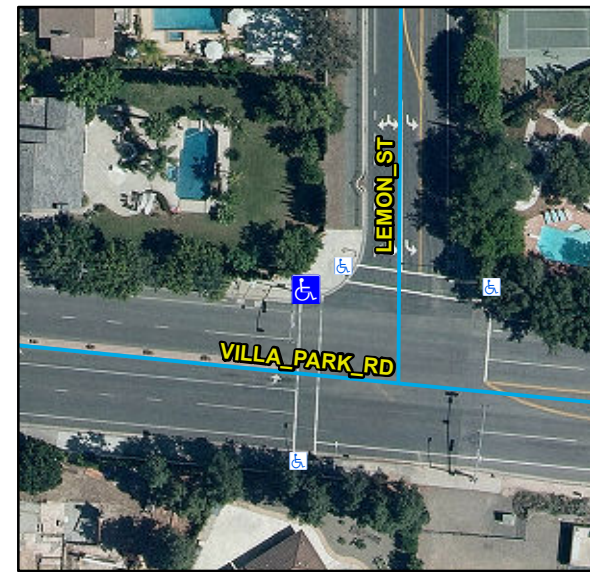
| Compliance | Description | Data | Compliance | Description | Data |
|---|---|---|---|---|---|
| No | Ramp Run Slope (%) | 9.2 | N/A | Flare Slope LT (%) | N/A |

**Remove & Replace Entire Ramp.**

**R304.2.2, STD 1115**
