# Access Compliance Report Public Rights-of-Way (Curb Ramps)

Main Street: LEMON\_ST Cross Street: VILLA\_PARK\_RD Location: NW

ADA ID: RPRK211222142127 Ramp Type: Type 1 - Perpendicular Initial Pass/Fail: Pass Overall Compliance: No Severity Score: 6

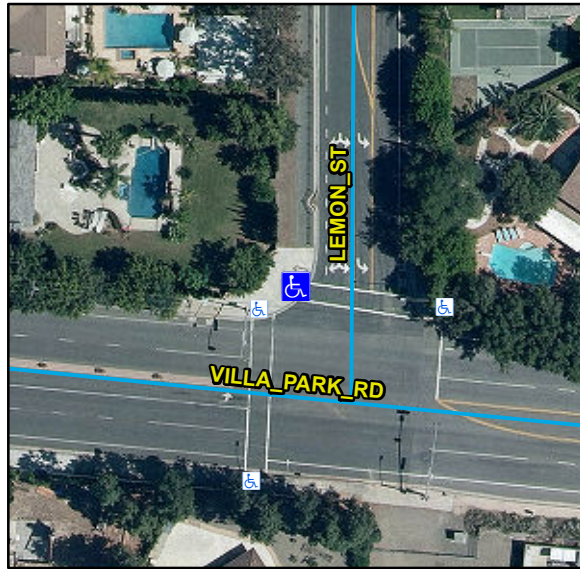
| Compliance | Description | Data | Compliance | Description | Data |
|---|---|---|---|---|---|
| Yes | Landing Run Slope (%) | 2 | N/A | Flare Traversable RT | No |
| No | Gutter Ponding | Yes | Yes | Curb Slope | 1.9 |
| No | Gutter Run Slope (%) | 12.2 | | Road Cross Slope (%) | N/A |

Remove & Replace Landing. Remove & Replace Gutter.

R304.2.1, R302.7, R304.5.4, STD 1115
