# Access Compliance Report Public Rights-of-Way (Curb Ramps)

Main Street: LEMON\_ST Cross Street: VILLA\_PARK\_RD Location: NE

ADA ID: RPRK211222142400 Ramp Type: Type 1 - Perpendicular Initial Pass/Fail: Fail Overall Compliance: No Severity Score: 16

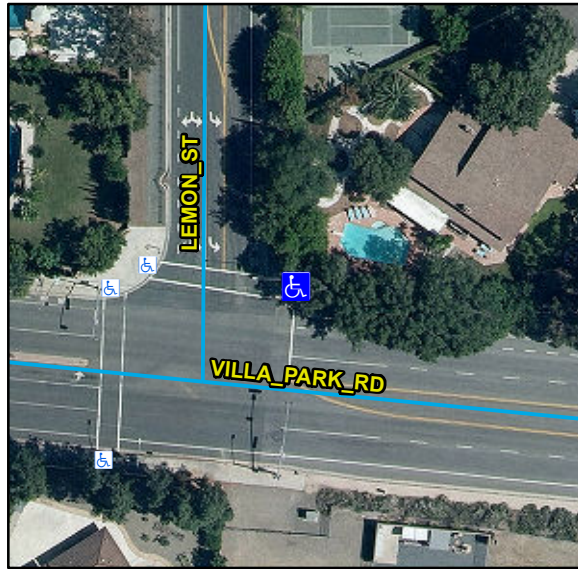
| Compliance | Description | Data | Compliance | Description | Data |
|---|---|---|---|---|---|
| No | Ramp Run Slope (%) | 10.5 | N/A | Flare Slope LT (%) | N/A |
| No | Ramp Cross Slope (%) | 2.6 | N/A | Flare Traversable LT | N/A |
| No | Gutter Lip Height (in) | 0.5 | | Road Run Slope (%) | N/A |

Remove & Replace Entire Ramp. Grind Gutter Lip.

R204.3, R304.2.2, R304.5.3, R302.7.2, STD 1115
