# Access Compliance Report Public Rights-of-Way (Curb Ramps)

| Main Street: S_ESPANITA_ST | | Cross Street: BOND_AVE | | Location: | SW |
| ADA ID: RPRK211223111713 | Ramp Type: Type 4 - Parallel | Initial Pass/Fail: Fail | Overall Compliance: No | Severity Score: | 15 |

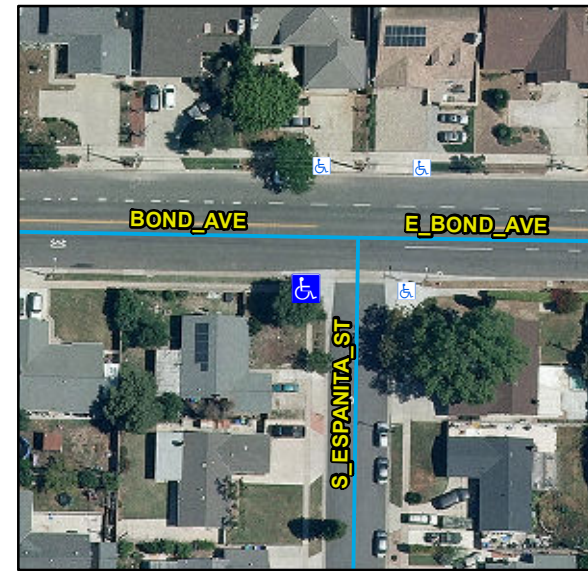
| Compliance | Description | Data | Compliance | Description | Data |
|---|---|---|---|---|---|
| No | Ramp Run Slope LT (%) | 8.7 | Yes | Ramp Run Slope RT (%) | 7.4 |

**Remove & Replace Curb Ramp With Two New Directional Ramps or Equivalent.**

**R304.3.2, STD 1115**

Total Cost: \$ 4000
