# Access Compliance Report Public Rights-of-Way (Curb Ramps)

| Main Street: RANCHO_SANTIAGO_BLV | | Cross Street: E_AVENIDA_PALMAR | | Location: | NE |
| ADA ID: RPRK211223122049 | Ramp Type: Type 4 - Parallel | Initial Pass/Fail: Fail | Overall Compliance: No | Severity Score: | 16 |

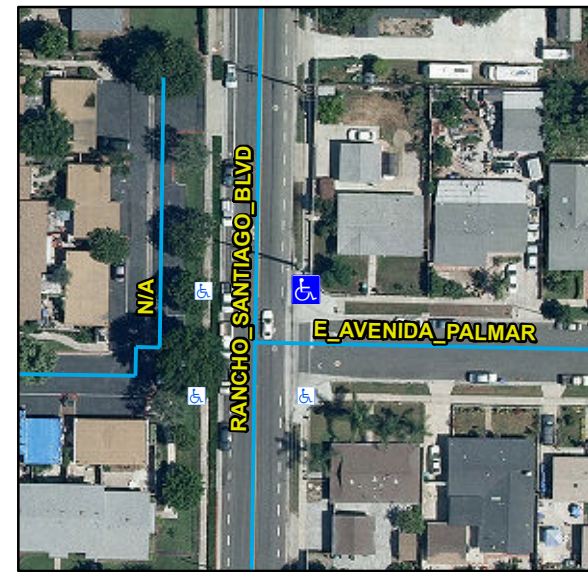
| Compliance | Description | Data | Compliance | Description | Data |
|---|---|---|---|---|---|
| Yes | Ramp Run Slope LT (%) | 4.8 | No | Ramp Run Slope RT (%) | 8.5 |
| No | Ramp Cross Slope LT (%) | 2.7 | Yes | Ramp Cross Slope RT (%) | 1.7 |

**Remove & Replace Curb Ramp With Two New Directional Ramps or Equivalent.**

**R304.5.3, R304.3.2, STD 1115**
