# Access Compliance Report Public Rights-of-Way (Curb Ramps)

| Main Street: TREASURE_LN | | Cross Street: ARROYO_AVE | | Location: | S |
| ADA ID: RPRK220125140822 | Ramp Type: Type 1 - Perpendicular Diagonal Initial Pass/Fail: Fail | | Overall Compliance: No | Severity Score: | 60 |

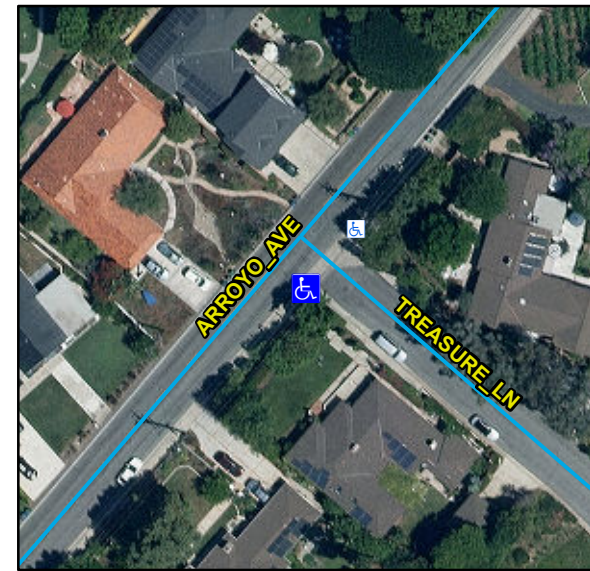
**R204.3, R304.2.2, R304.5.3, R302.7.2, STD 1115**

| Compliance | Description | Data | Compliance | Description | Data |
|---|---|---|---|---|---|
| No | Ramp Run Slope (%) | 13.8 | N/A | Flare Slope LT (%) | N/A |
| No | Ramp Cross Slope (%) | 11.5 | N/A | Flare Traversable LT | N/A |
| No | Gutter Lip Height (in) | 0.25 | | Road Run Slope (%) | 7.9 |

**Remove & Replace Curb Ramp With Two New Directional Ramps or Equivalent. Grind Gutter Lip.**
