# Access Compliance Report Public Rights-of-Way (Curb Ramps)

| Main Street: MCFADDEN_AVE | | Cross Street: VAN_BUREN_ST | | Location: | S |
| ADA ID: RPRK220202120214 | Ramp Type: Type 4 - Parallel | Initial Pass/Fail: Fail | Overall Compliance: No | Severity Score: | 16 |

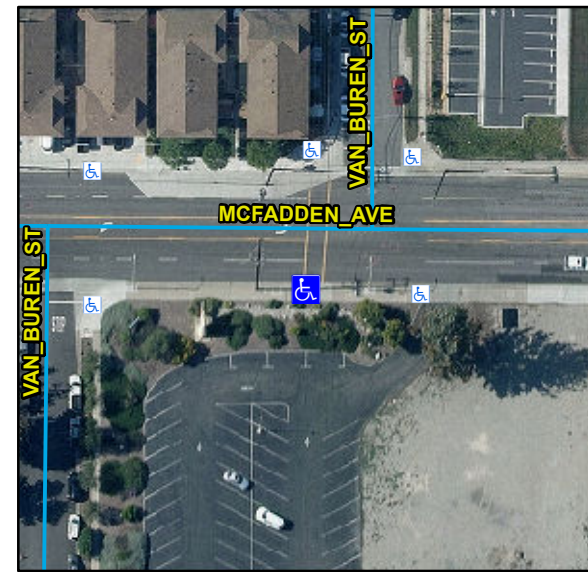
R304.3.2, R304.5.3, STD 1115

| Compliance | Description | Data | Compliance | Description | Data |
|---|---|---|---|---|---|
| No | Ramp Run Slope LT (%) | 9.3 | No | Ramp Run Slope RT (%) | 9.1 |
| No | Ramp Cross Slope LT (%) | 2.2 | No | Ramp Cross Slope RT (%) | 2.3 |

Remove & Replace Entire Ramp.
