# Access Compliance Report Public Rights-of-Way (Curb Ramps)

Main Street: PUERTO\_PL Cross Street: N/A Location: SE

ADA ID: RPRK220208152409 Ramp Type: Type 1 - Perpendicular Initial Pass/Fail: Fail Overall Compliance: No Severity Score: 16

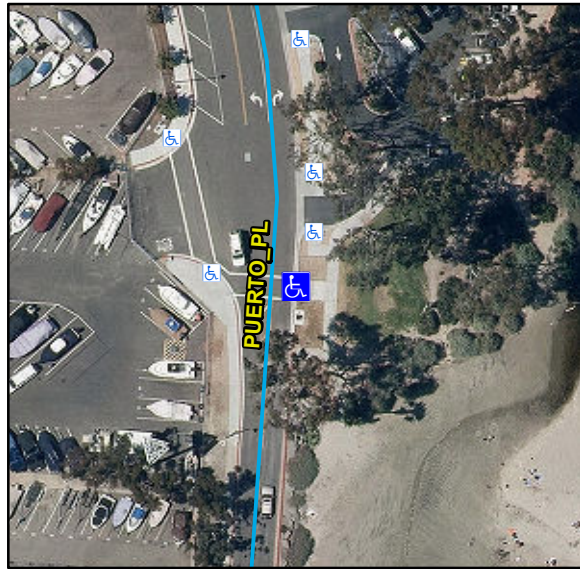
| Compliance | Description | Data | Compliance | Description | Data |
|---|---|---|---|---|---|
| No | Ramp Run Slope (%) | 8.5 | N/A | Flare Slope LT (%) | N/A |

Remove & Replace Entire Ramp.

R304.2.2, STD 1115
