# Access Compliance Report Public Rights-of-Way (Curb Ramps)

| Main Street: EMBARCADERO_PL | | Cross Street: DANA_POINT_HARBOR_DR | | Location: | SE |
| ADA ID: RPRK220208154928 | Ramp Type:Type 1 - Perpendicular | Initial Pass/Fail: Fail | Overall Compliance: No | Severity Score: | 2 |

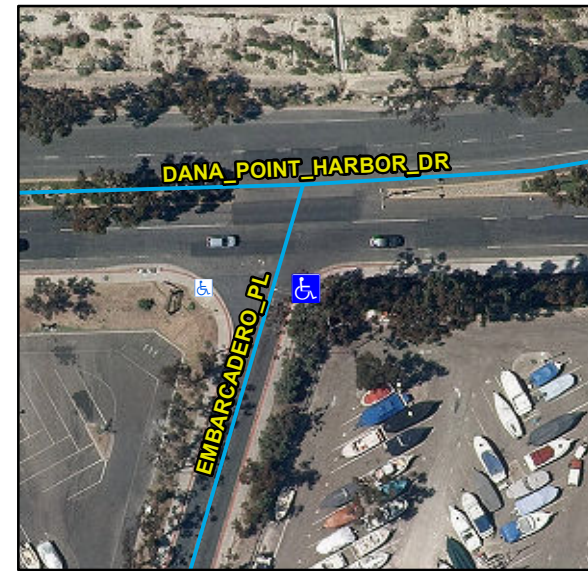
| Compliance | Description | Data | Compliance | Description | Data |
|---|---|---|---|---|---|
| No | Ramp Cross Slope (%) | 2.1 | N/A | Flare Traversable LT | N/A |

Remove & Replace Entire Ramp.

R204.3, R304.5.3, STD 1115
