# Access Compliance Report Public Rights-of-Way (Curb Ramps)

| Main Street: EMBARCADERO_PL | | Cross Street: DANA_POINT_HARBOR_DR | | Location: | SW |
| ADA ID: RPRK220208155140 | Ramp Type:Type 1 - Perpendicular | Initial Pass/Fail: Fail | Overall Compliance: No | Severity Score: | 16 |

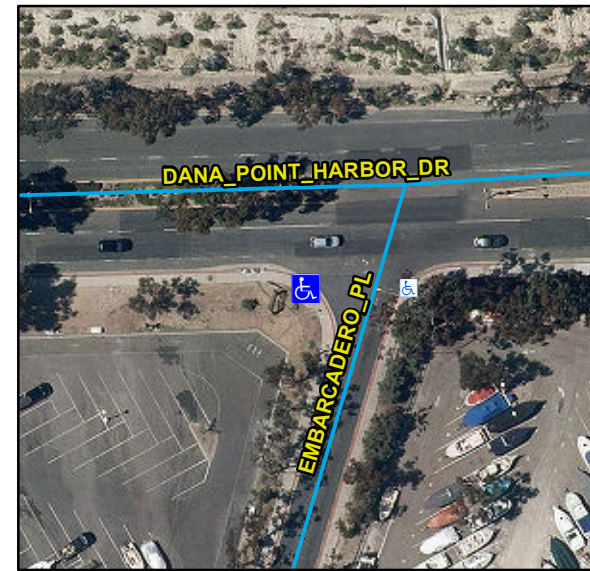
| Compliance | Description | Data | Compliance | Description | Data |
|---|---|---|---|---|---|
| No | Ramp Run Slope (%) | 11.2 | N/A | Flare Slope LT (%) | N/A |
| No | Ramp Cross Slope (%) | 4.9 | N/A | Flare Traversable LT | N/A |

**Remove & Replace Entire Ramp.**

**R204.3, R304.2.2, R304.5.3, STD 1115**
