# Access Compliance Report Public Rights-of-Way (Curb Ramps)

Main Street: DANA\_POINT\_HARBOR\_DR Cross Street: CASITAS\_PL Location: SE

ADA ID: RPRK220208170810 Ramp Type: Type 1 - Perpendicular Diagonal Initial Pass/Fail: Pass Overall Compliance: No Severity Score: 4

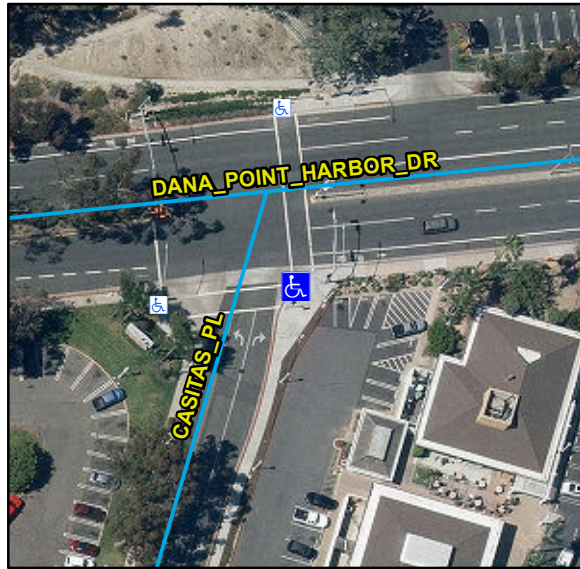
| Compliance | Description | Data | Compliance | Description | Data |
|---|---|---|---|---|---|
| No | Landing Cross Slope (%) | 2.3 | Yes | DWS Provided | Yes |
| No | Gutter Ponding | Yes | Yes | Curb Slope | 0.9 |

Remove & Replace Landing. Gutter Ponding Observed.

R304.2.1, R304.5.3, R302.7, STD 1115
