# Access Compliance Report Public Rights-of-Way (Curb Ramps)

| Main Street: ISLAND_WAY | | Cross Street: DANA_POINT_HARBOR_DR | | Location: | W |
| ADA ID: RPRK220208172915 | Ramp Type:Type 1 - Perpendicular | Initial Pass/Fail: Fail | Overall Compliance: No | Severity Score: | 16 |

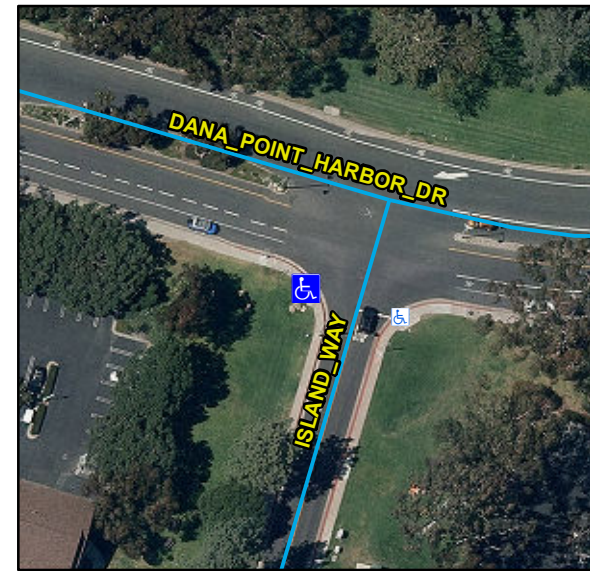
R204.3, R304.2.2, R304.5.3, STD 1115

| Compliance | Description | Data | Compliance | Description | Data |
|---|---|---|---|---|---|
| No | Ramp Run Slope (%) | 11.9 | N/A | Flare Slope LT (%) | N/A |
| No | Ramp Cross Slope (%) | 2.5 | N/A | Flare Traversable LT | N/A |

Remove & Replace Entire Ramp.
