# Access Compliance Report Public Rights-of-Way (Curb Ramps)

| Main Street: ISLAND_WAY | | Cross Street: DANA_POINT_HARBOR_DR | | Location: | S |
| ADA ID: RPRK220208173039 | Ramp Type:Type 1 - Perpendicular | Initial Pass/Fail: Fail | Overall Compliance: No | Severity Score: | 30 |

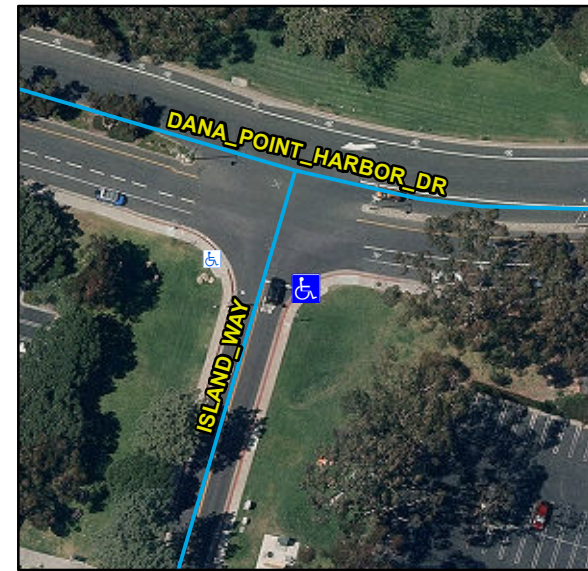
| Compliance | Description | Data | Compliance | Description | Data |
|---|---|---|---|---|---|
| No | Ramp Run Slope (%) | 17.4 | N/A | Flare Slope LT (%) | N/A |

Remove & Replace Entire Ramp.

R204.3, R304.2.2, STD 1115
