# Access Compliance Report Public Rights-of-Way (Curb Ramps)

Main Street: N/A Cross Street: DANA\_POINT\_HARBOR\_DR Location: S

ADA ID: RPRK220208175725 Ramp Type: Type 1 - Perpendicular Initial Pass/Fail: Fail Overall Compliance: No Severity Score: 15

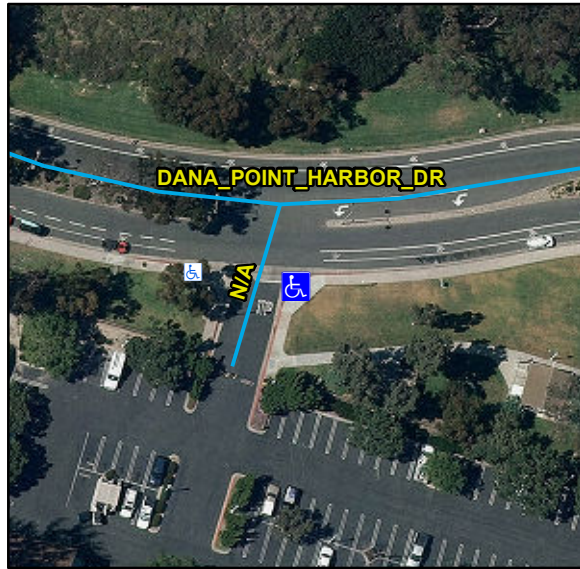
R204.3, R304.2.2, STD 1115

| Compliance | Description | Data | Compliance | Description | Data |
|---|---|---|---|---|---|
| No | Ramp Run Slope (%) | 11.8 | N/A | Flare Slope LT (%) | N/A |

Remove & Replace Entire Ramp.
