# Access Compliance Report Public Rights-of-Way (Curb Ramps)

Main Street: N/A Cross Street: DANA\_POINT\_HARBOR\_DR Location: W

ADA ID: RPRK220208175938 Ramp Type: Type 1 - Perpendicular Initial Pass/Fail: Fail Overall Compliance: No Severity Score: 16

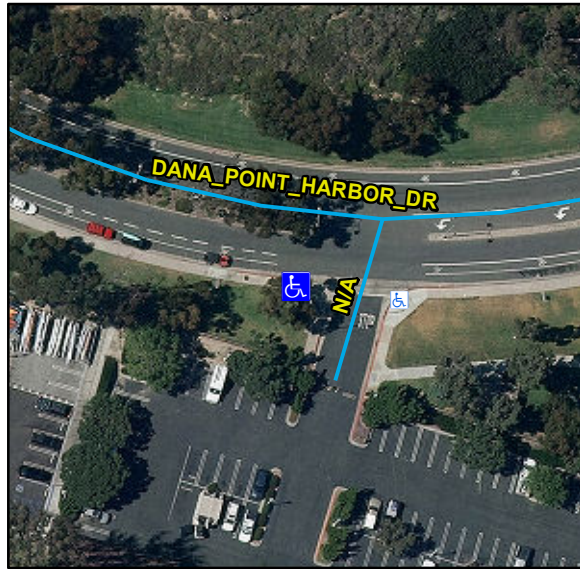
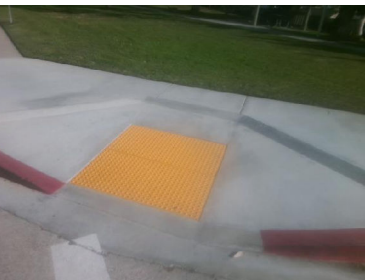
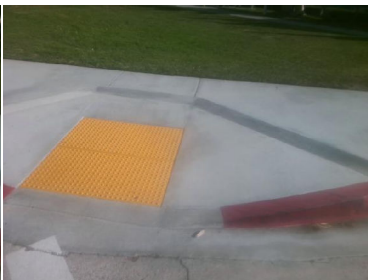
| Compliance | Description | Data | Compliance | Description | Data |
|---|---|---|---|---|---|
| No | Ramp Run Slope (%) | 8.8 | N/A | Flare Slope LT (%) | N/A |

Possible Solutions:

Remove & Replace Entire Ramp.

R304.2.2, STD 1115
