# Access Compliance Report Public Rights-of-Way (Curb Ramps)

Main Street: COVE\_RD Cross Street: DANA\_POINT\_HARBOR\_DR Location: N

ADA ID: RPRK220208180215 Ramp Type: Type 1 - Perpendicular Initial Pass/Fail: Fail Overall Compliance: No Severity Score: 16

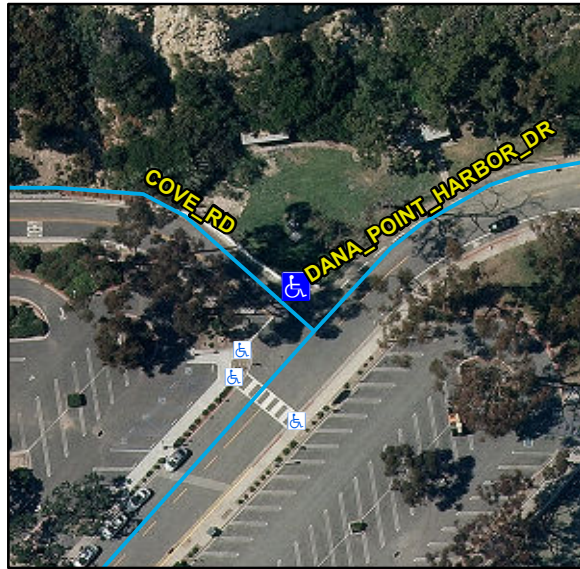
| Compliance | Description | Data | Compliance | Description | Data |
|---|---|---|---|---|---|
| No | Ramp Run Slope (%) | 9 | N/A | Flare Slope LT (%) | N/A |

Remove & Replace Entire Ramp.

R304.2.2, STD 1115
