# Access Compliance Report Public Rights-of-Way (Curb Ramps)

Main Street: MT\_GUSTIN\_ST Cross Street: EDINGER\_AVE Location: NE

ADA ID: RPRK220222164156 Ramp Type: Type 1 - Perpendicular Diagonal Initial Pass/Fail: Fail Overall Compliance: No Severity Score: 15

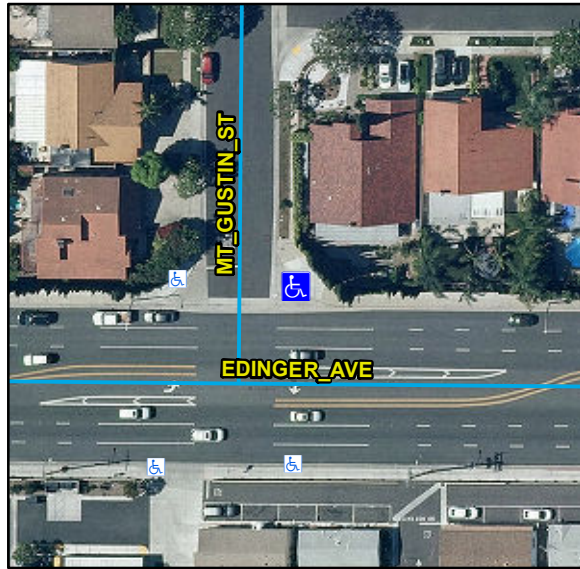
| Compliance | Description | Data | Compliance | Description | Data |
|---|---|---|---|---|---|
| No | Ramp Run Slope (%) | 8.5 | N/A | Flare Slope LT (%) | N/A |
| No | Gutter Lip Height (in) | 0.4 | | Road Run Slope (%) | 0.4 |

Remove & Replace Curb Ramp With Two New Directional Ramps or Equivalent. Grind Gutter Lip.

R304.2.2, R302.7.2, STD 1115
