# Access Compliance Report Public Rights-of-Way (Curb Ramps)

Main Street: ESENCIA\_DR Cross Street: ESENCIA\_DR Location: NW

ADA ID: RPRK220225195215 Ramp Type: Type 1 - Perpendicular Initial Pass/Fail: Pass Overall Compliance: No Severity Score: 2

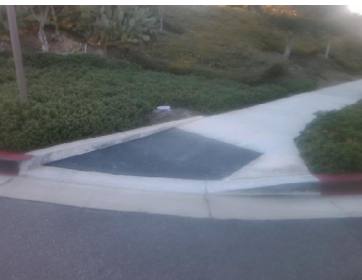
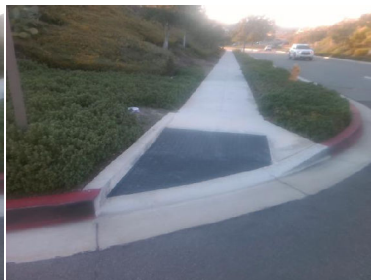
| Compliance | Description | Data | Compliance | Description | Data |
|---|---|---|---|---|---|
| Yes | Gutter Ponding | No | No | Curb Slope | 11.4 |
| No | Gutter Cross Slope (%) | 2.3 | | | |

Remove & Replace Curb Slope. Remove & Replace Gutter.
