# Access Compliance Report Public Rights-of-Way (Curb Ramps)

Main Street: PUERTO\_PL Cross Street: PUERTO\_PL Location: N

ADA ID: RPRK220225202645 Ramp Type: Type 1 - Perpendicular Initial Pass/Fail: Fail Overall Compliance: No Severity Score: 15

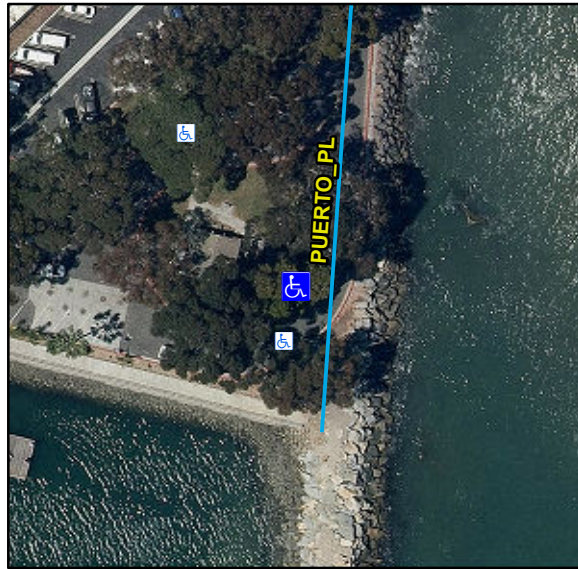
| Compliance | Description | Data | Compliance | Description | Data |
|---|---|---|---|---|---|
| No | Ramp Run Slope (%) | 8.6 | N/A | Flare Slope LT (%) | N/A |

Possible Solutions:

Remove & Replace Entire Ramp.

R304.2.2, STD 1115
