### Villa Park Dam (Main Dam) (E08D01) - Monitoring Survey

This earthen dam was built in 1963. The first survey was performed in 1963. This report displays all surveys from 1963 to present. Horizontal displacement is compared to dam survey line. Vertical displacement are compared to the 1963 survey.

### Villa Park Dam (Auxiliary Dam) - Monitoring Survey

### <u>Villa Park Dam (Outlet Structure) - Monitoring Survey</u>

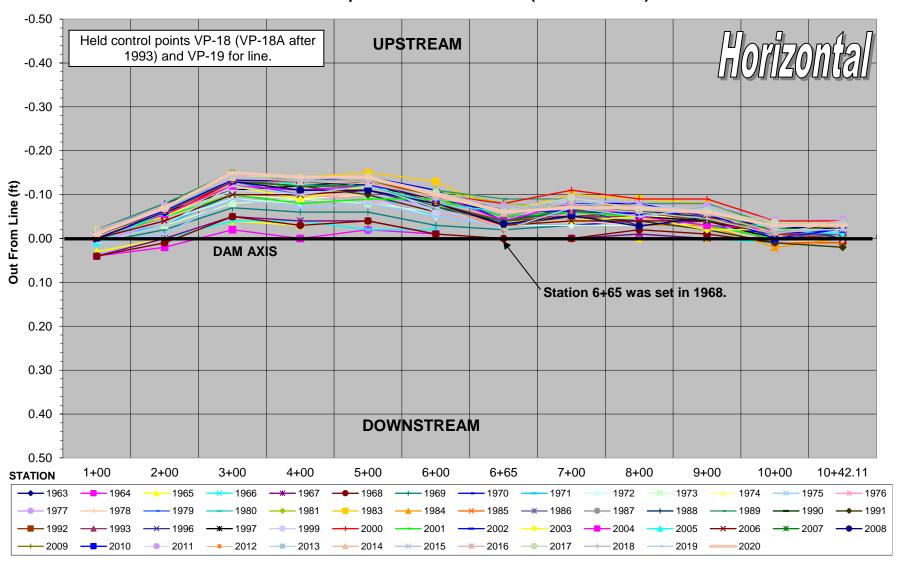
Villa Park (Main) Dam Horizontal Movement Perpendicular to Dam Axis (Out From Line) - Plan View

1963-1973	Gradual subsidence measured due to settling of dam. Upstream horizontal movement measured, mostly concentrated around stations 3+00 thru 5+00.
1974-1977	Upstream horizontal movement and subsidence still measured. Rates are Gradually slowing.
1978-1988	Subsidence continues at a very slow rate. Horizontal appears stable.
1989-2000	Vertical subsidence has discontinued. Horizontal appears stable.
2001	No significant movement detected.
2002	No significant movement detected.
2003	No significant movement detected.
2004	No significant movement detected.
2005	No significant movement detected.
2006	No significant movement detected.
2007	No significant movement detected.
2008	No significant movement detected.
2009	No significant movement detected.
2010	No significant movement detected.
2011	No significant movement detected.
2012	No significant movement detected.
2013	No significant movement detected.
2014	No significant movement detected.

2015	No significant movement detected.
2016	No significant movement detected.
2017	No significant movement detected.
2018	No significant movement detected.
2019	No significant movement detected.
2020	No significant movement detected.
2021

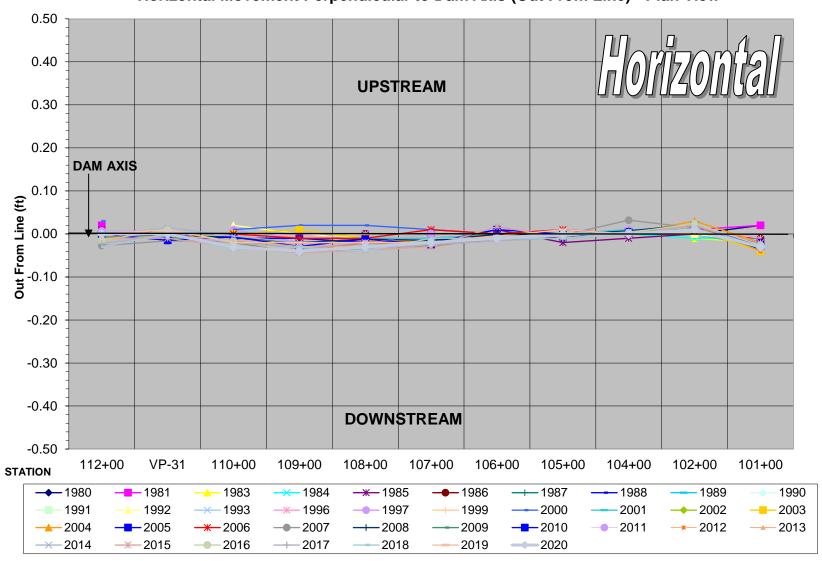
Villa Park (Auxiliary) Dam Horizontal Movement Perpendicular to Dam Axis (Out From Line) - Plan View

1980-1990	Monuments appear to be stable horizontally and vertically. No significant movement detected.
1991-2000	Monuments continue to be stable horizontally and vertically. No significant movement detected.
2001	No significant movement detected.
2002	No significant movement detected.
2003	No significant movement detected.
2004	No significant movement detected.
2005	No significant movement detected.
2006	No significant movement detected.
2007	No significant movement detected.
2008	No significant movement detected.
2009	No significant movement detected.
2010	No significant movement detected.
2011	No significant movement detected.
2012	No significant movement detected.
2013	No significant movement detected.
2014	No significant movement detected.
2015	No significant movement detected.
2016	100+00 shows subsidence of 0.10'. No significant movement detected.
2017	No significant movement detected.
2018	No significant movement detected.

2019	No significant movement detected.
2020	No significant movement detected.
2021	
2022

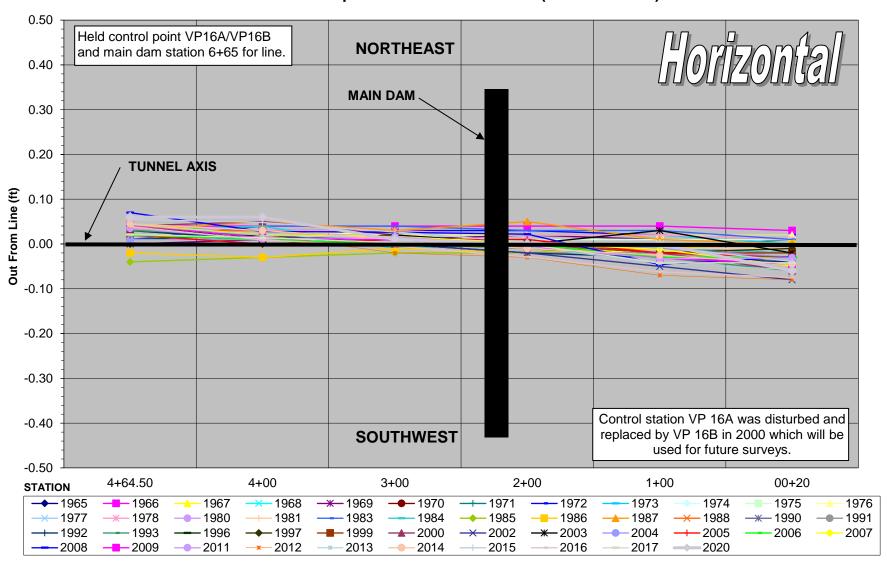
Villa Park (Outlet) Dam
Horizontal Movement Perpendicular to Tunnel Axis (Out From Line) - Plan View

1964-1984	Horizontally stable. Vertical subsidence occurs due to settling of dam
1985-1999	Horizontally stable. Vertical subsidence seems to stop. No significant movement detected.
2000	Horizontal chart differs from previous surveys due to change in control stations. Vertical appears stable. No significant movement detected.
2001	No survey performed due to excessive water in tunnel.
2002	No significant movement detected.
2003	No significant movement detected.
2004	No significant movement detected.
2005	No significant movement detected.
2006	No significant movement detected.
2007	No significant movement detected.
2008	No significant movement detected.
2009	No significant movement detected.
2010	VP Tunnel not monitored. GPS Point #1039 (VP-16B) was underwater; point is unusable until the water is drained from this area.
2011	No significant movement detected.
2012	No significant movement detected.
2013	No significant movement detected.

2014	No significant movement detected.
2015	No significant movement detected.
2016	No significant movement detected.
2017	No significant movement detected.
2018	Structure not monitored due to unsafe conditions.
2019	Structure not monitored due to unsafe conditions.
2020	No significant movement detected.
2021	
2022
