OC Survey Island Way Bridge NE quay wall Dana Point Harbor

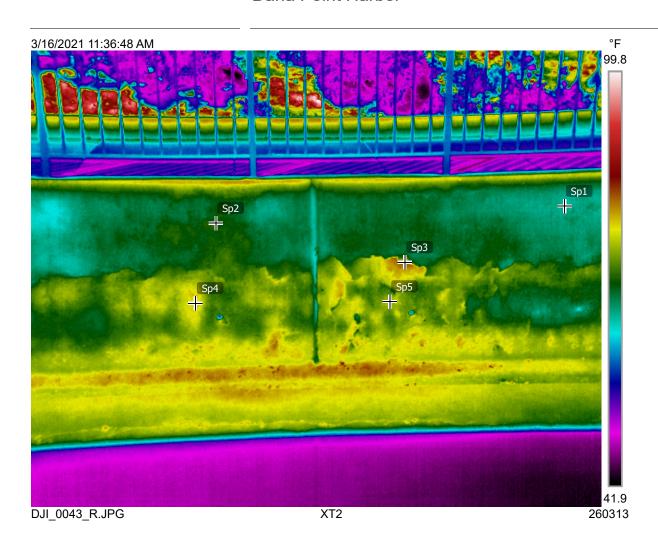
DCIM/100MEDIA/DJI_0043_R.JPG

Sp1	68.0 °F
Sp2	73.4 °F
Sp3	84.5 °F
Sp4	80.3 °F
Sp5	77.4 °F

Thermal image of Island Way Bridge north east quay wall. The image was collected using a DJI Matrice 210 with a FLIR XT2 camera. The temperatures recorded are apparent temperatures only not precise temperatures.

The image illustrates the possible delamination hot spots of the face of the qual wall indicated by the difference in temperature. The warmer temperature indicates the heat flux within the concrete.
