**AS BUILT**

| TALBERT - MACARTHUR BRIDGE ACROSS SANTA ANA RIVER | | | |
| DEMOLITION DETAILS | | | |

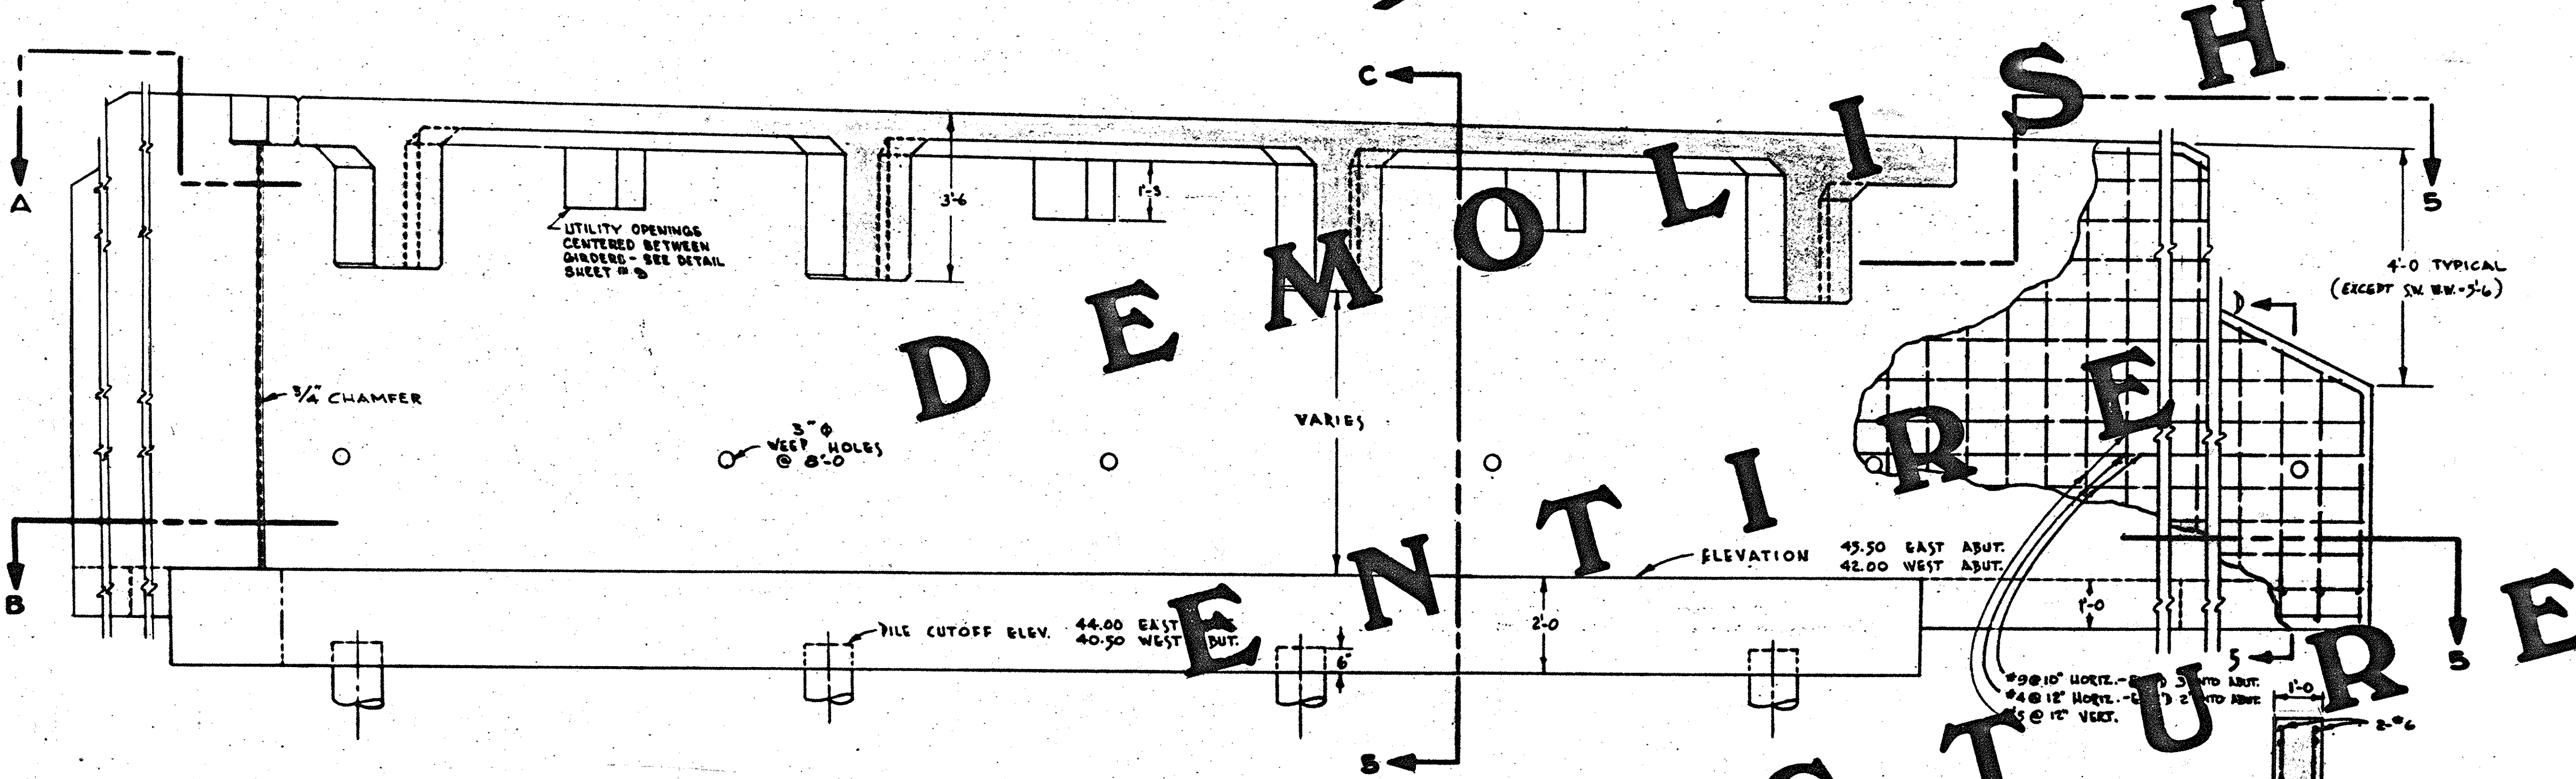
TYPICAL ABUTMENT DETAIL  
(WEST ABUTMENT LOOKING WEST)

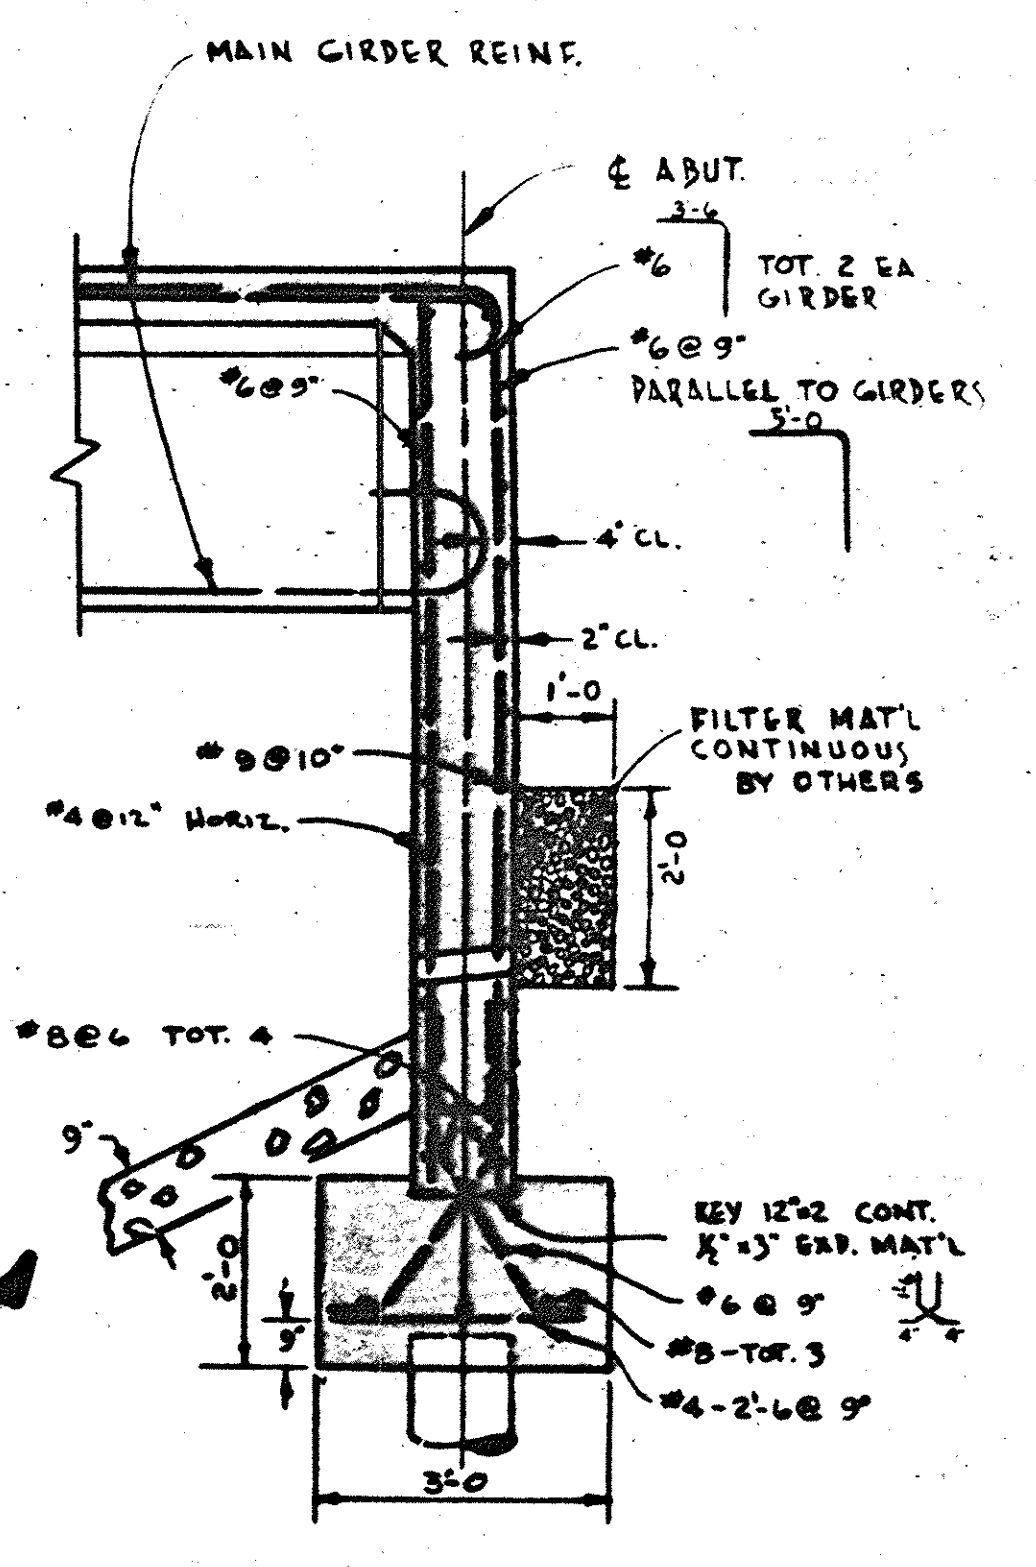
SECTION C-C  
NOTE: BLOCK BACK OF UNUSED UTILITY OPENINGS WITH 2" MIN. REDWOOD. EDGE LAD MIN. 3" BY OTHERS
