Bridge No. 24  
Lane Rd. Bridge  
2.60 mi. e/o Newport Ave.  
Sheet 1 of 2  
Scale - as shown  
Tollon

ORANGE COUNTY ROAD DEPT.  
PILE RECORD  
LANE RD. BRIDGE  
2.60 MI. EAST OF NEWPORT AVE.  
STRUCTURE S-24  
JUL 5 1940  
Dec. 1943

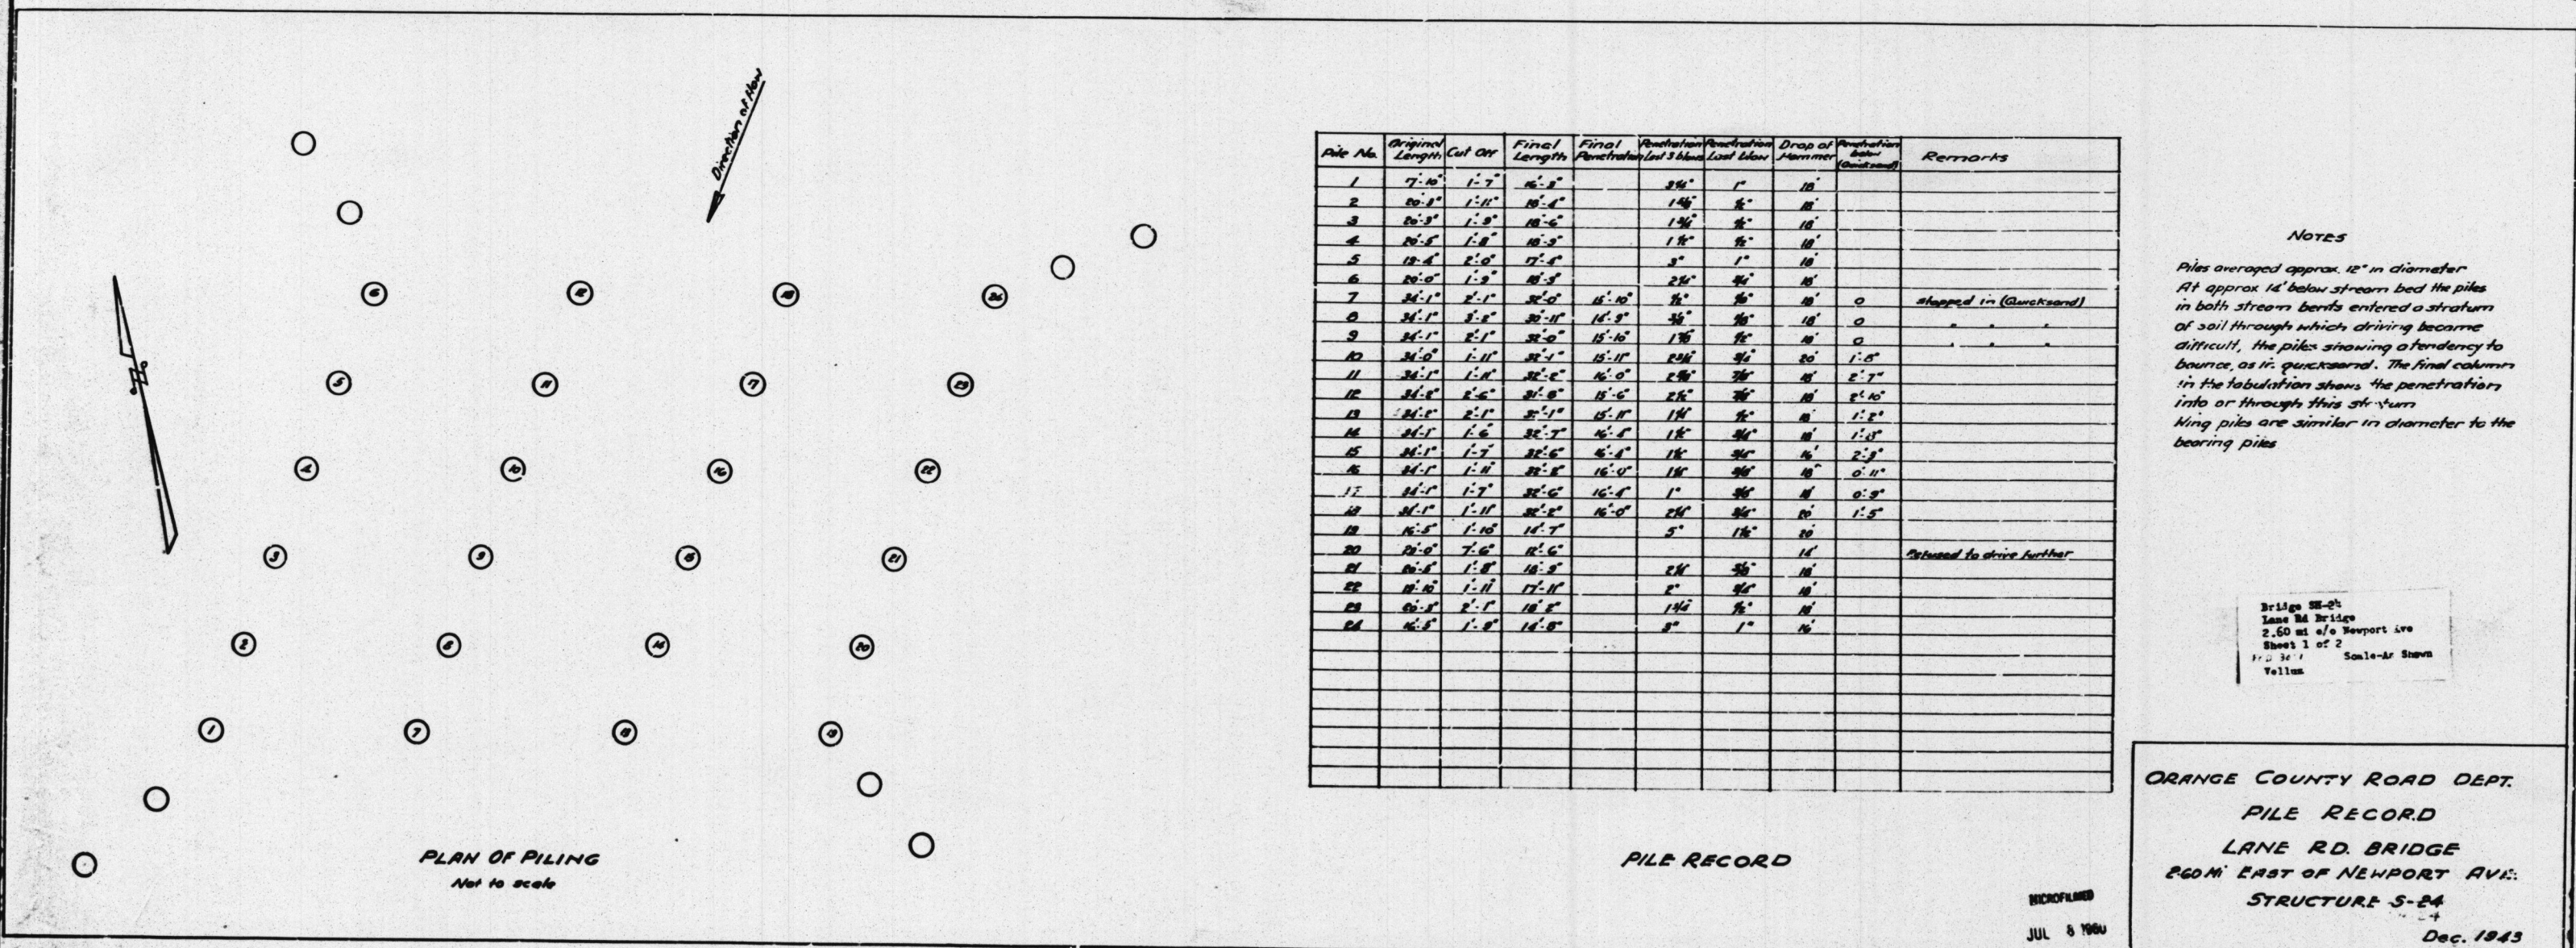
NOTES  
Piles averaged approx. 12" in diameter.  
At approx. 14' below stream bed the piles in both stream bents entered a stratum of soil through which driving became difficult, the piles showing a tendency to bounce, as in quicksand. The final columns in the tabulation show the penetration into or through this stratum.  
King piles are similar in diameter to the bearing piles.
