# Bridge Inspection Records Information System

Bridge Number : 55C0344  
Facility Carried: ADAMS AVE  
Location : 0.5 MI E BROOKHURST ST  
City :  
Inspection Date : 08/13/2001

**Bridge Inspection Report**

**Name : SANTA ANA RIVER CHANNEL**

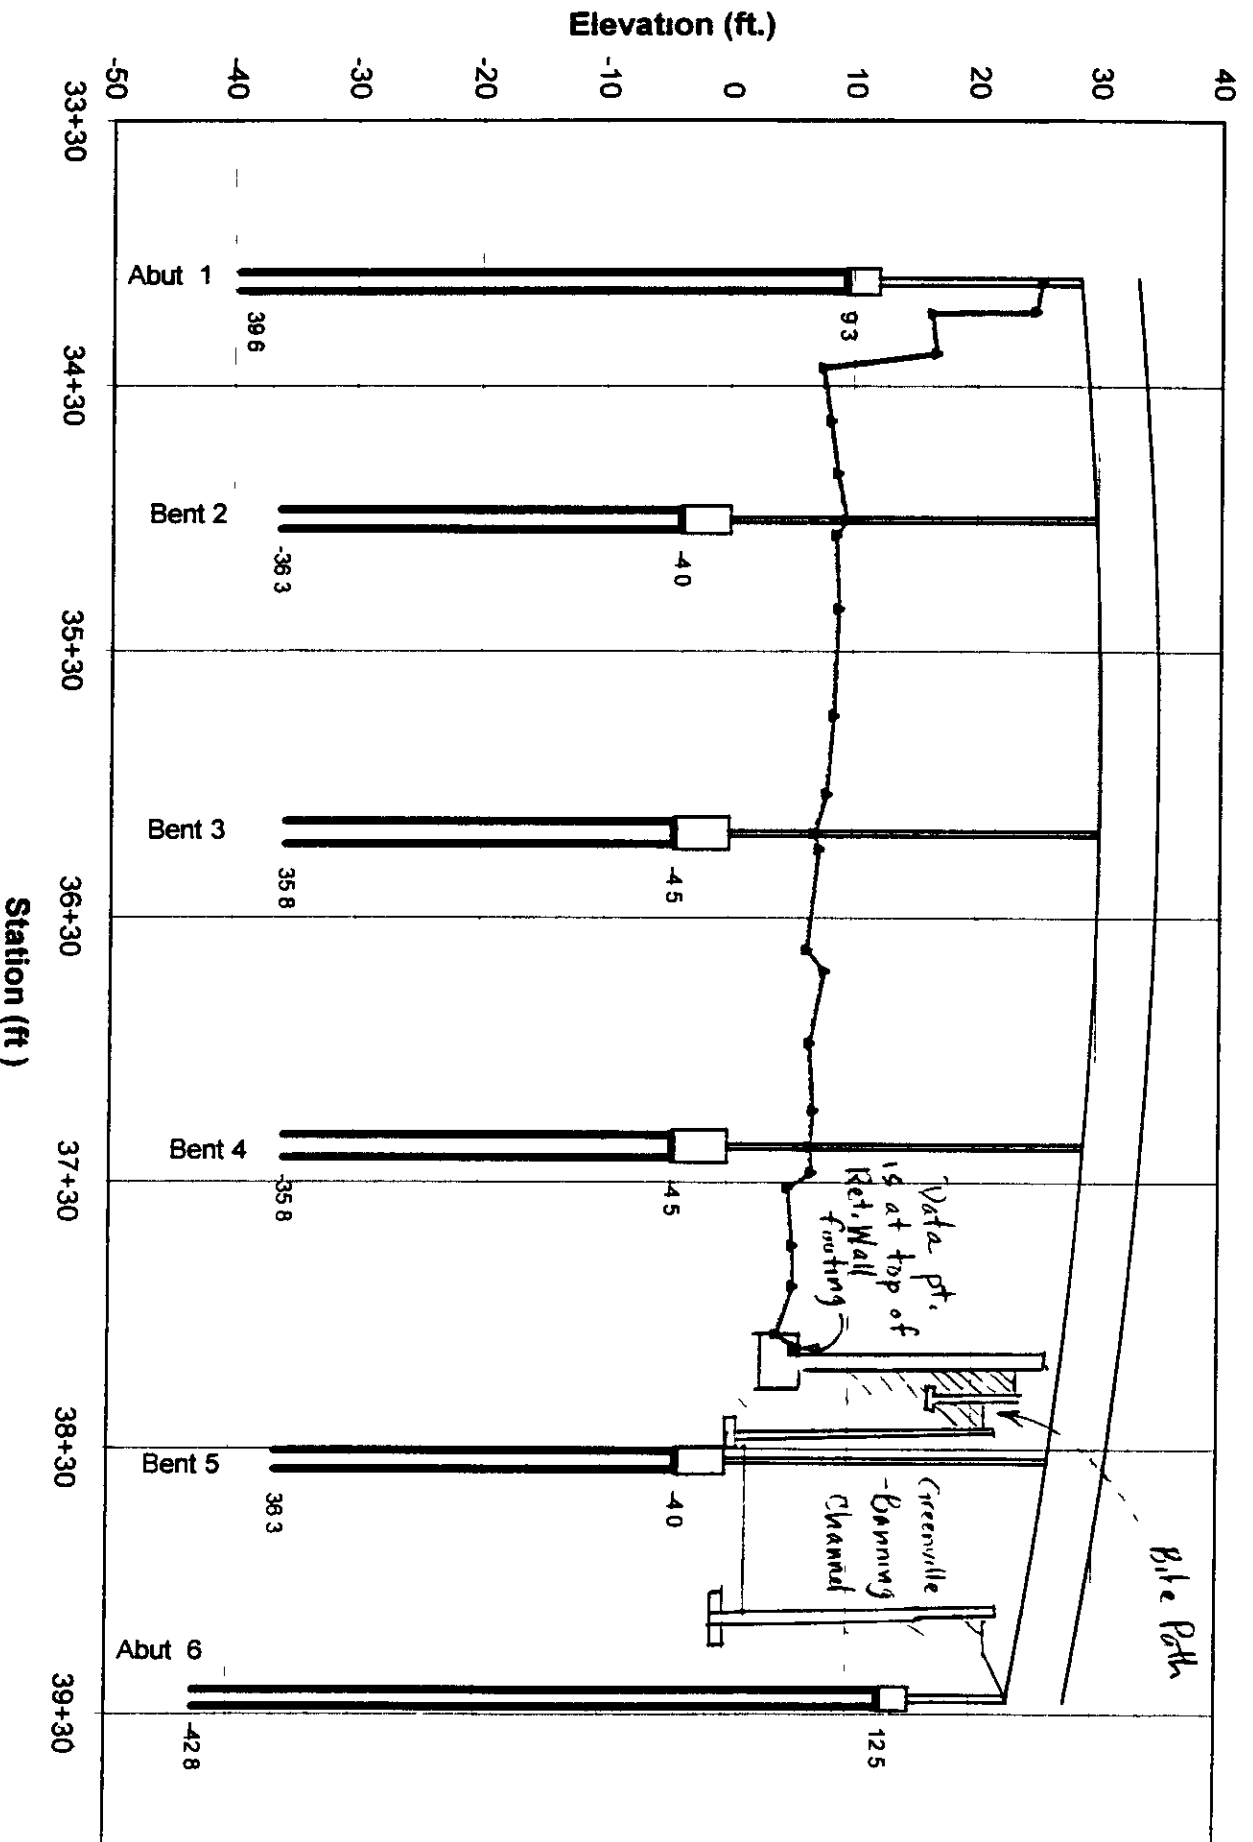
**CHANNEL X-SECTION**

The sandy channel bed appears self-leveling, however several unbalanced deposits of sand were observed.

Both banks, up and downstream, are lined with reinforced concrete, vertical walls as described above. The only exposed footing was observed along the retaining wall in Span 4, near Pier 5 and the bike path. Rock riprap has been placed along the footing. The adjacent channel bed is approximately 0.4 m below the top of footing. The retaining wall height is approximately 6.71 m, does not meet the bridge soffit and is independent of the bridge foundation. The Greenville-Banning Channel lies under Span 5 and is a fully lined concrete channel. Drift accumulation at piers, abutment scour and local pier scour was not observed during this investigation. Piers are aligned with flow and hydraulic skew is not an issue.

The preliminary scour calculations indicate the calculated scour elevation is greater than the allowable scour elevation. Historical channel cross-sections do not exist, however the channel appears to be aggrading and no long-term degradation is anticipated. Therefore, this bridge is not scour critical.

Side : Upstream

X-Section Date : 13-AUG-01

Measured From : Channel grade to soffit.

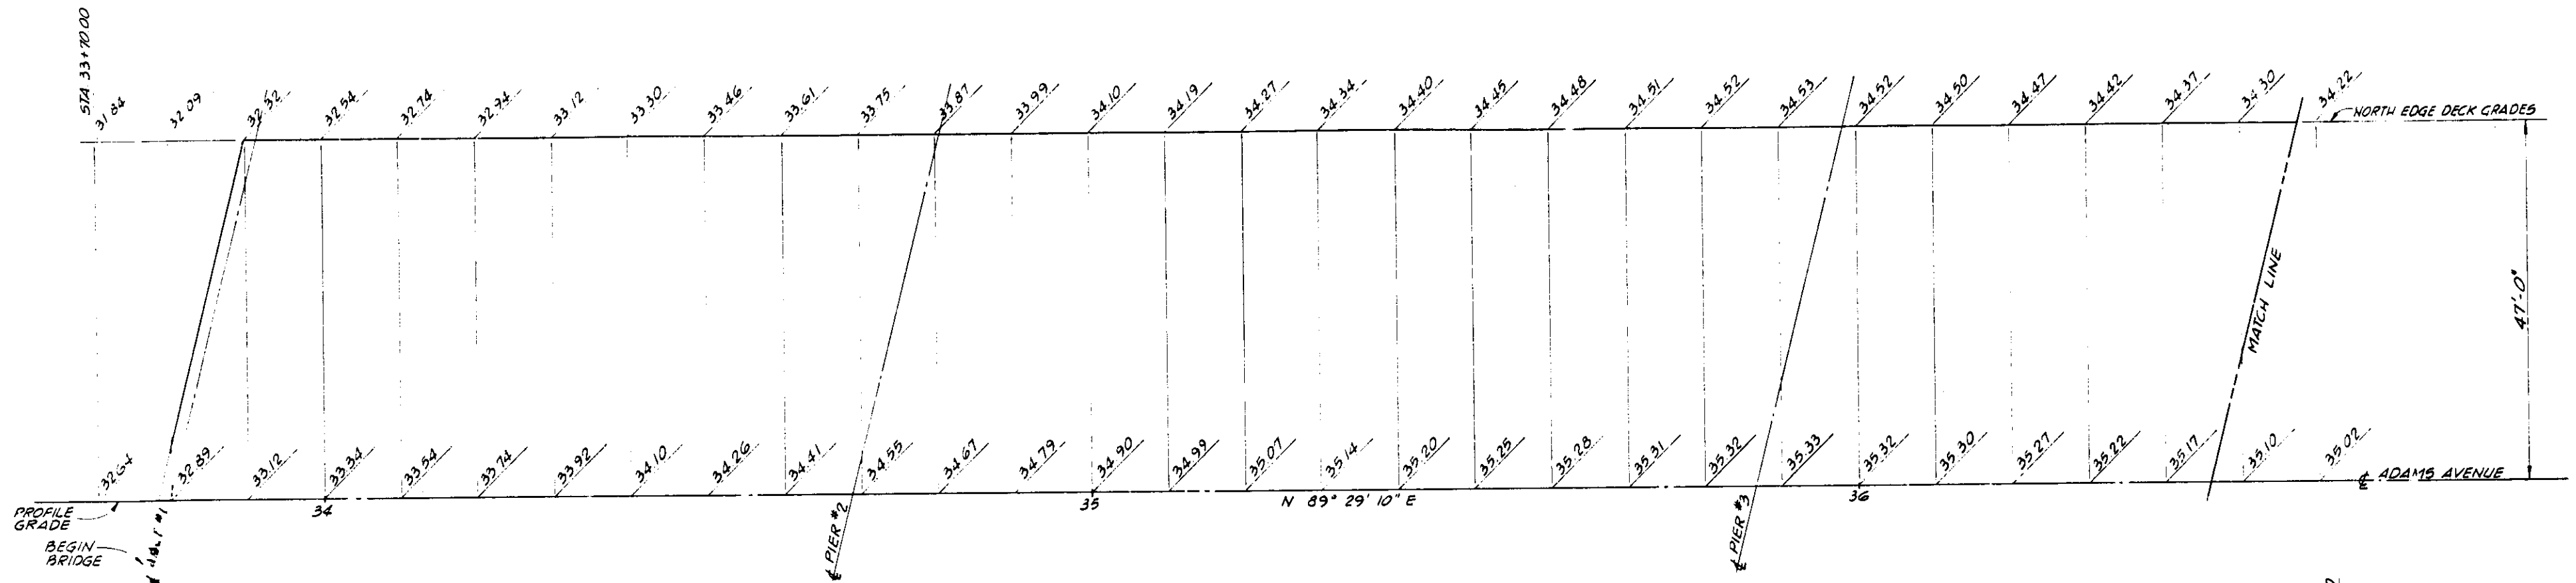
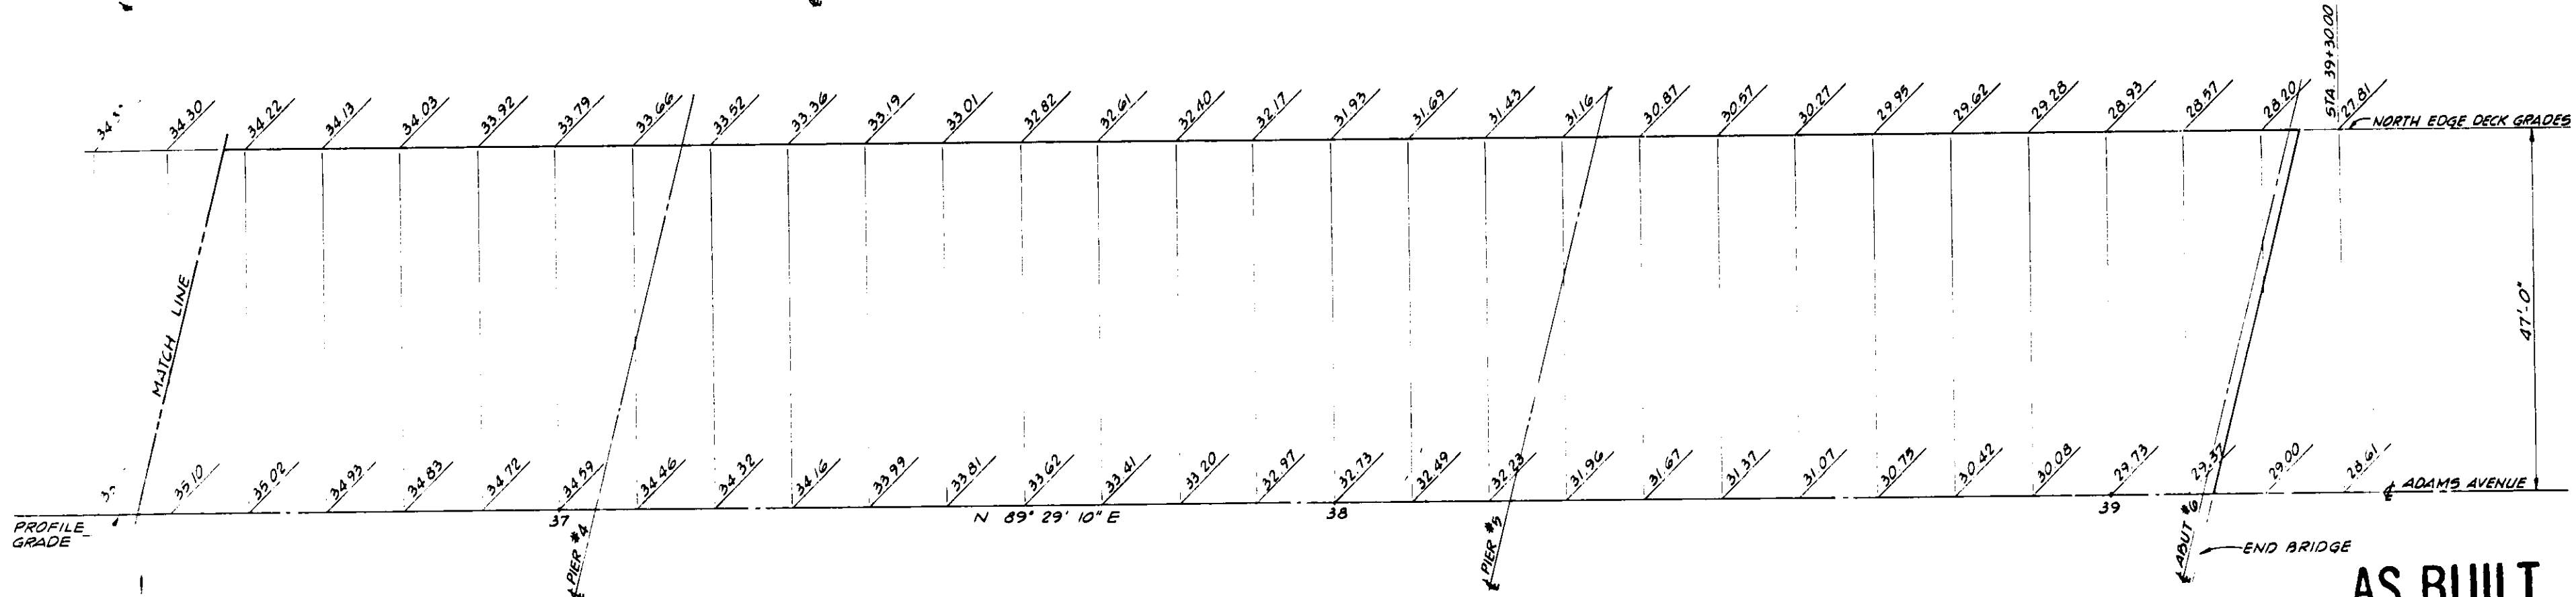
**PLAN - 10' GRID DECK ELEVATIONS**  
 SCALE: 1" = 10'-0"  
 (LEFT BRIDGE SHOWN; RIGHT BRIDGE SIMILAR)

NOTE:  
 ELEVATIONS ARE FIGURED NORMAL FROM PROFILE GRADE AT 10' STATIONS ALONG ADAMS AVENUE. THESE ELEVATIONS DO NOT INCLUDE CAMBER. ELEVATIONS ARE SYMMETRICAL ABOUT & ADAMS AVENUE.

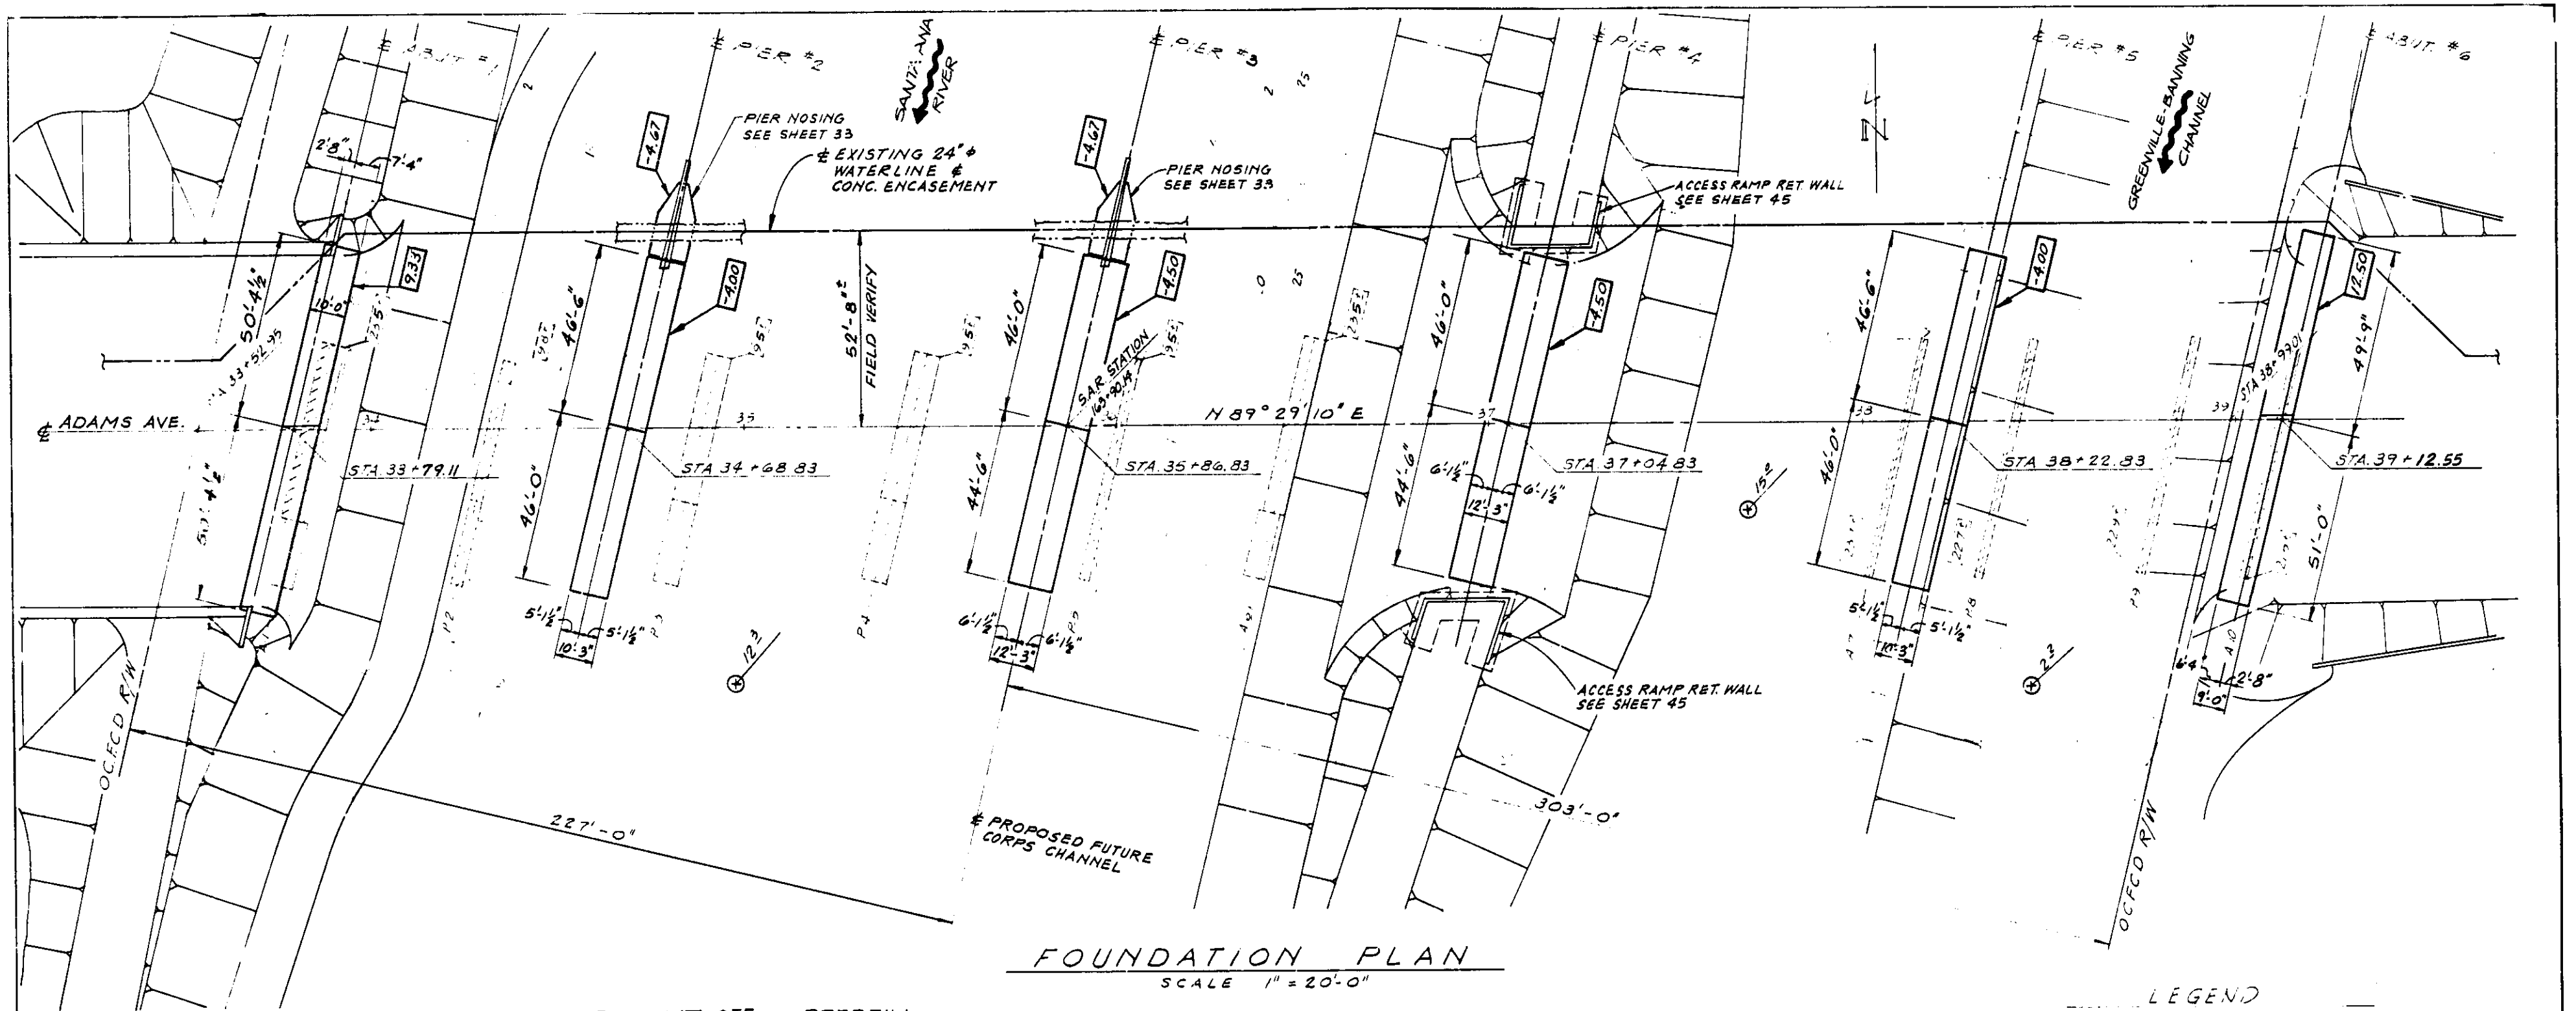
# FOUNDATION PLAN

1. THE CONTRACTOR SHALL FIELD LOCATE THE EXISTING 24" WATERLINE PRIOR TO FINAL DRILLING AND PILE DRIVING. PREDRILLING TIP ELEVATIONS SHALL BE AS NOTED OR TO 5'-0" BELOW WATERLINE ENCASEMENT WHICHEVER IS LOWER WITHIN 10'-0" OF WATERLINE ENCASEMENT.
2. THE 24" WATERLINE SHALL BE MAINTAINED IN SERVICE AND SHALL BE SHORED, BRACED AND PROTECTED DURING ALL CONSTRUCTION OPERATIONS.
3. ALL JETTING MUST BE SUSPENDED AND THE PILE DRIVEN FOR THE LAST 10 FEET TO SPECIFIED BEARING.

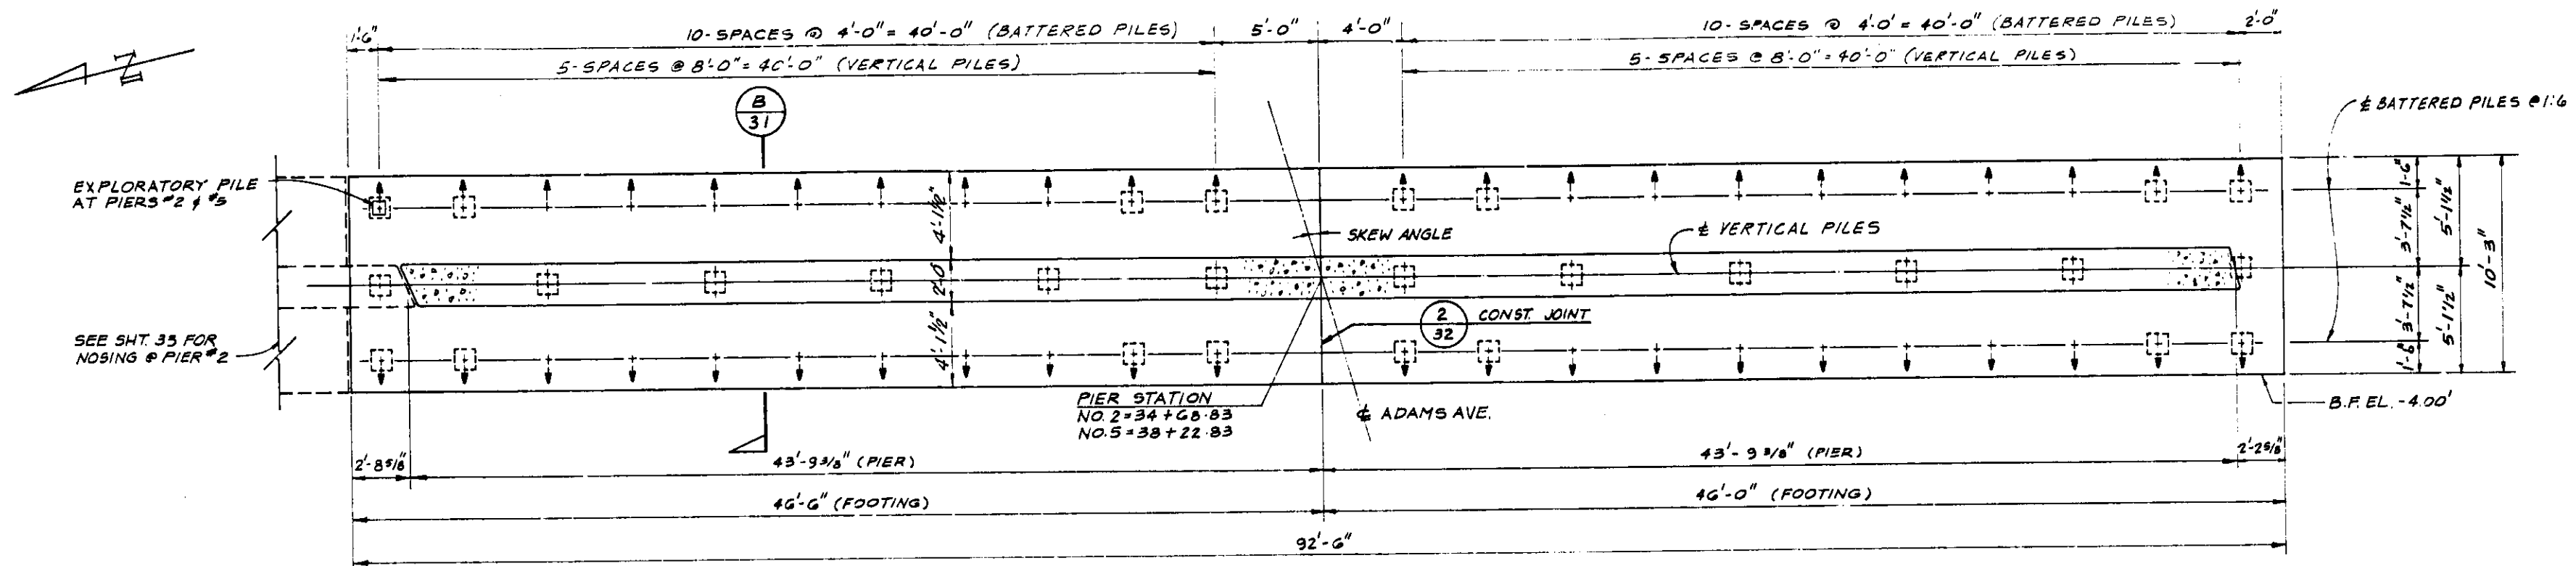
PIER NO. 2 & 5  
 PIER FOOTING & PILE LAYOUT-PLAN (A)  
 SCALE: 1/4" = 1'-0"

TOTAL 56 PILES PER PIER  
 44 BATTERED @ 1:6  
 12 VERTICAL

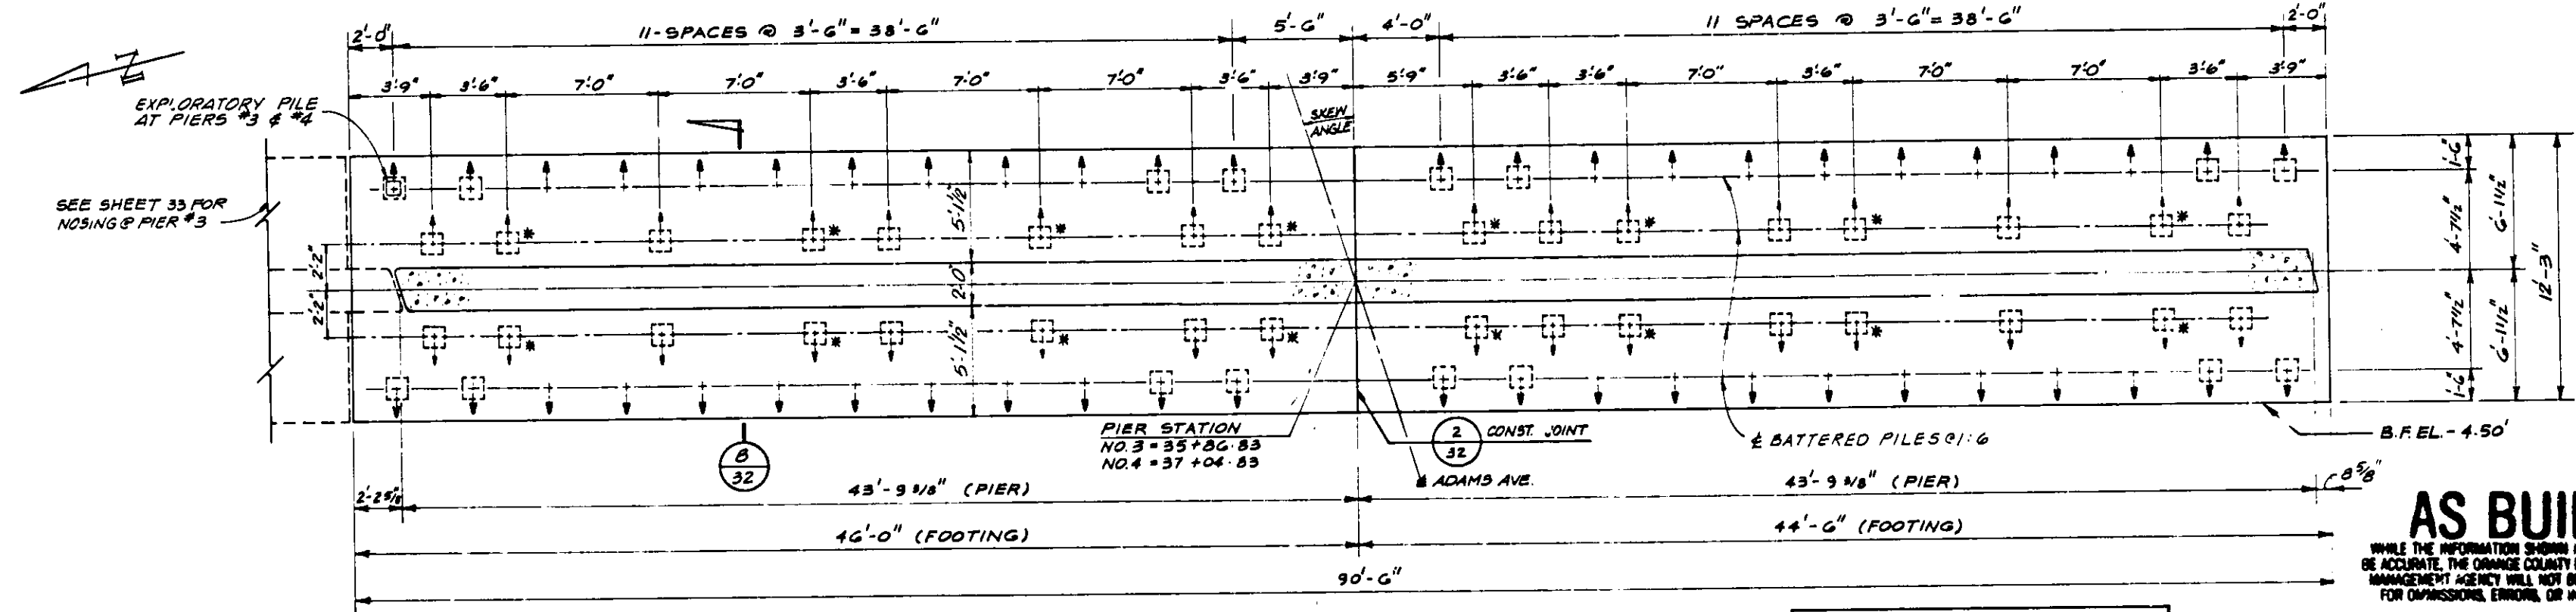
PIER NO. 3 & 4  
 PIER FOOTING & PILE LAYOUT-PLAN (B)  
 SCALE: 1/4" = 1'-0"

PIER #3 - 64 PILES ALL BATTERED 1:6  
 PIER #4 - 80 PILES ALL BATTERED 1:6  
 \* OMIT PILE @ PIER #3

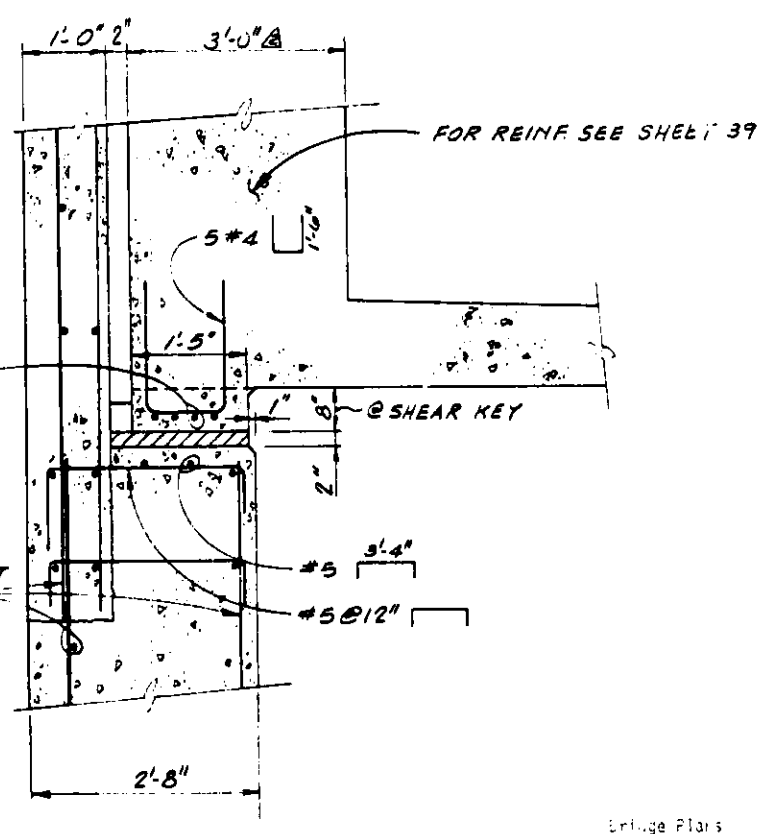
**SECTION D**  
SCALE: 3/4"=1'-0"

**NOTE:**  
\* SHEAR KEY REINFORCING TO BE BENT WITH STIRRUP HOOK BEND.

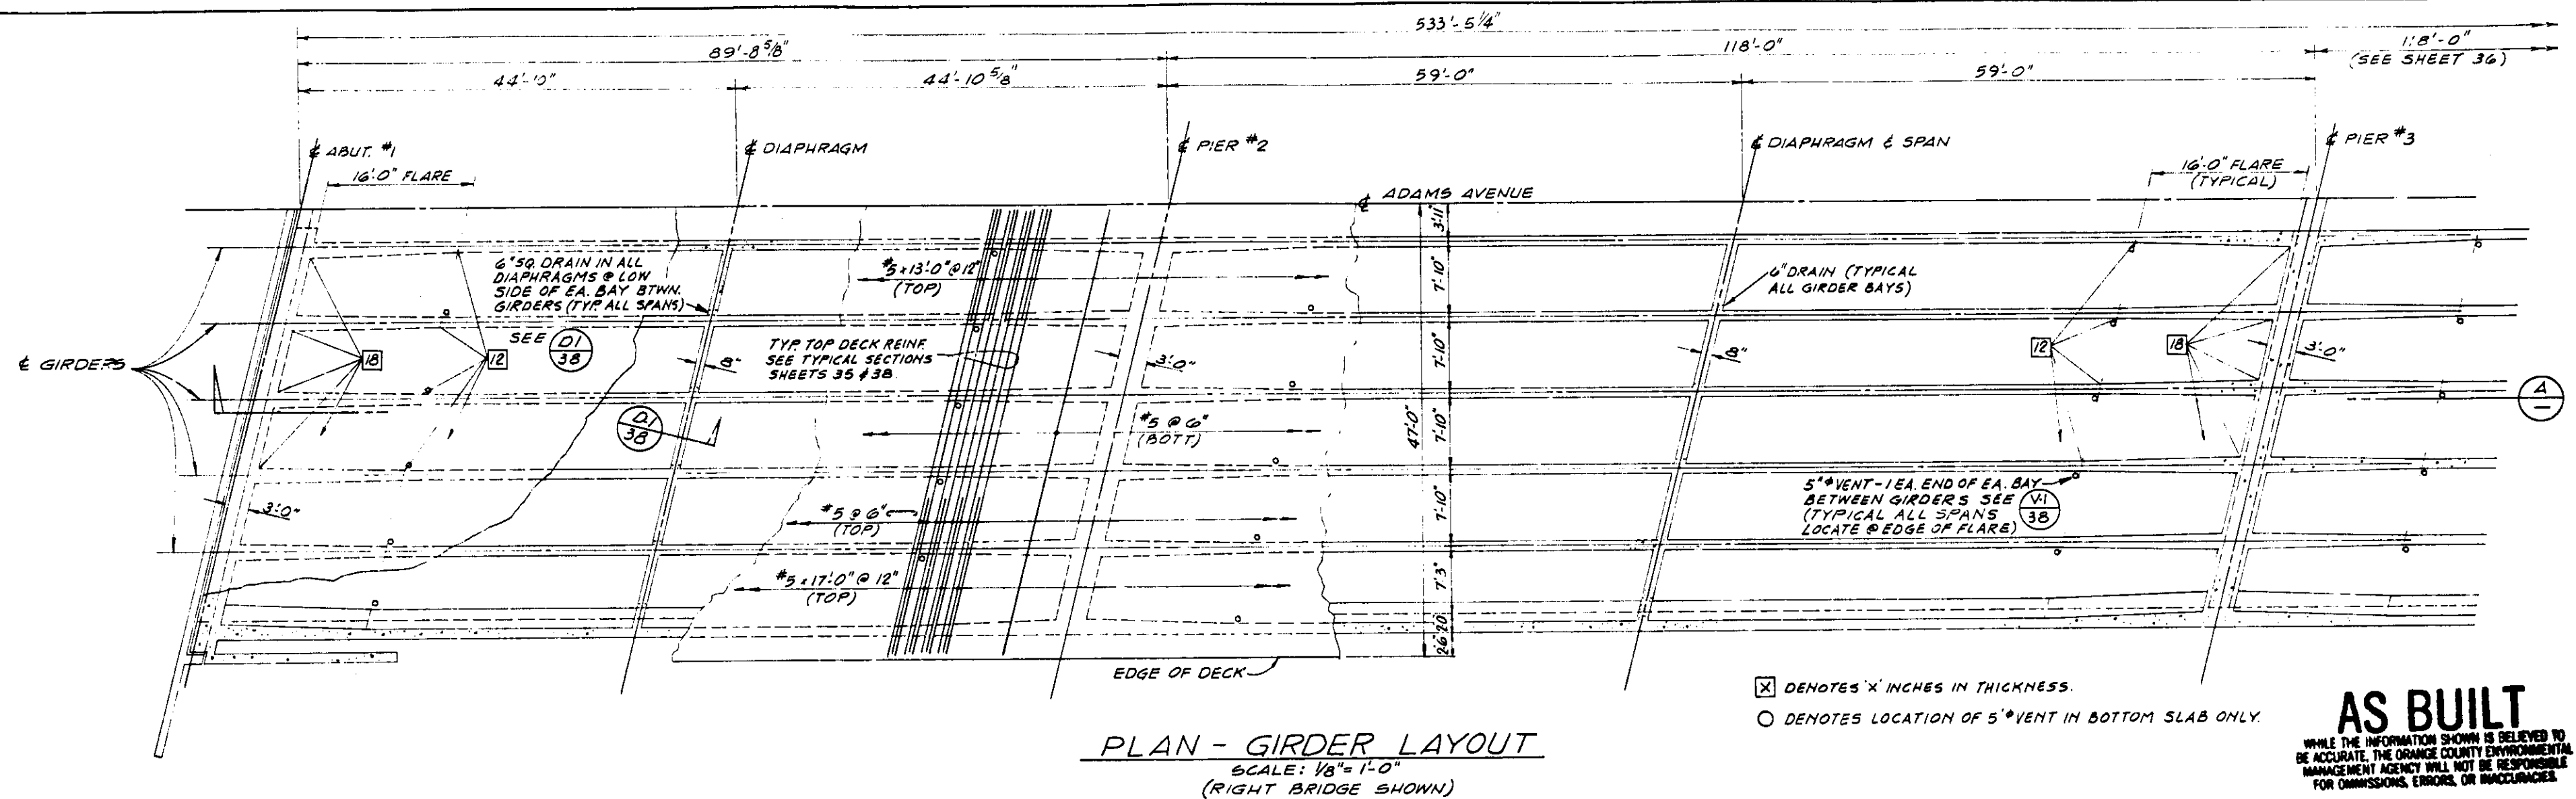
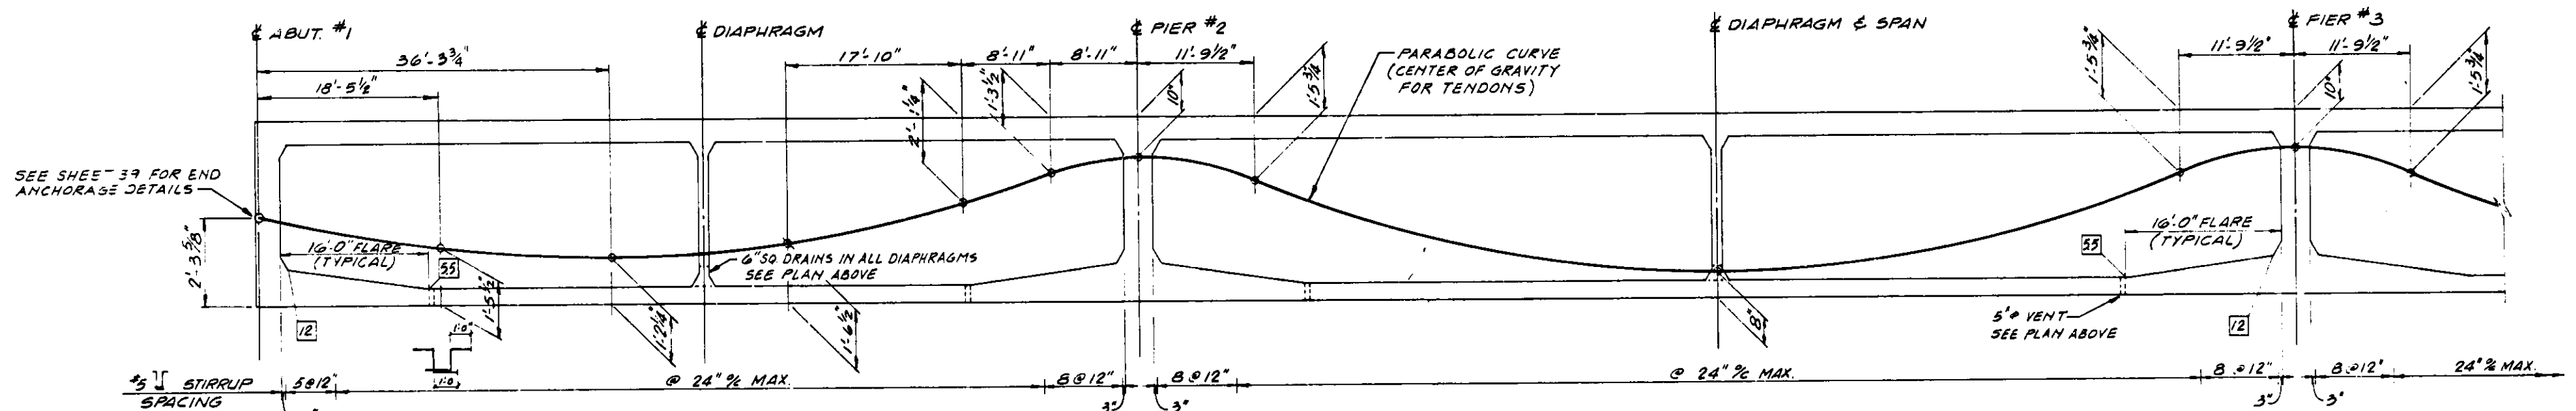
LONGITUDINAL SECTION (A) TYPICAL ALL GIRDERS

AS DEFLECTIONS MAY VARY WITH DIFFERENT PRESTRESSING SYSTEMS,  
CAMBER DIAGRAM SHALL BE VERIFIED AFTER SHOP DRAWINGS  
HAVE BEEN REVIEWED

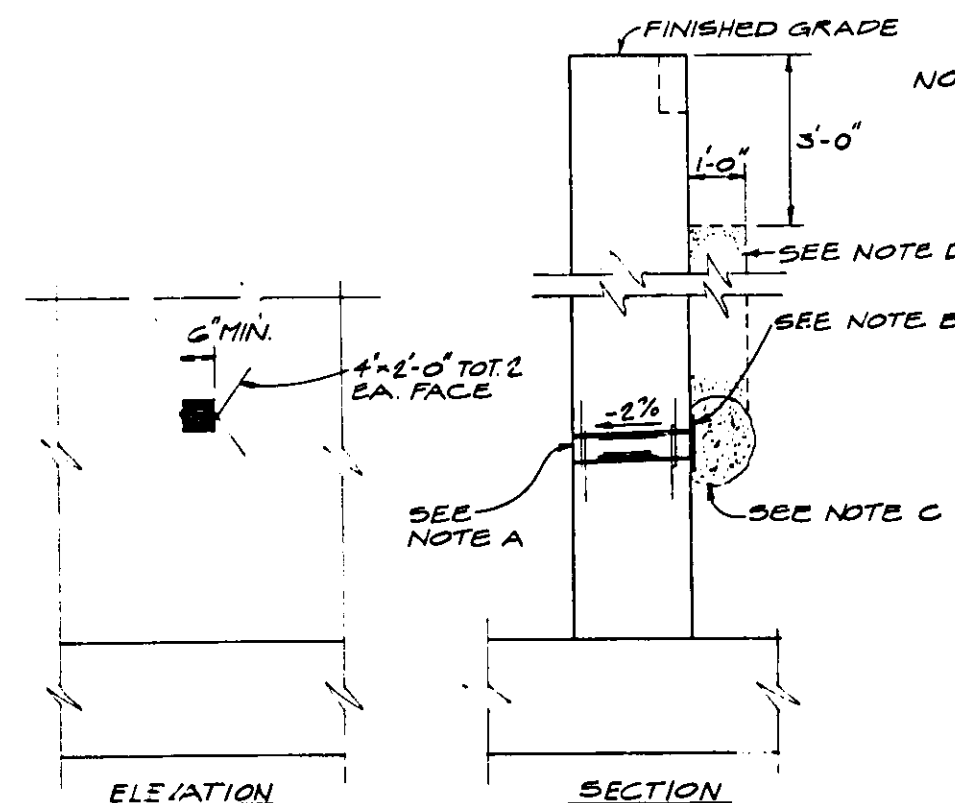
WEEP HOLE AND PERVIOUS BACKFILL  
BRIDGE DETAIL (8)

- NOTES:
- A. 4"  $\phi$  DRAINS @ 24' MAX. CENTER TO CENTER RETAINING WALLS AND 9'-3" C-C FOR ABUTMENT #1 & #6 WALL DRAINS SHALL BE LOCATED 3"  $\pm$  ABOVE FINISHED GRADE.
  - B. 6" SQUARE ALUMINUM OR GALVANIZED STEEL WIRE 4 MESH HARDWARE CLOTH. (MIN. WIRE DIAMETER 0.03") ANCHOR FIRMLY TO BACKFACE.
  - C. ONE CUBIC FOOT PERVIOUS BACKFILL MATERIAL IN A BURLAP SACK, SECURELY TIED
  - D. PERVIOUS BACKFILL MATERIAL CONTINUOUS BEHIND RETAINING WALL OR ABUTMENT
