# Access Compliance Report Public Rights-of-Way (Island Curb Cuts)

Main Street: ESENCIA\_DR Cross Street: ESENCIA\_DR Location: W

ADA ID: CCAT220208104214 Curb Cut Type: MedianRefuge2 Initial Pass/Fail: Fail Overall Compliance: No Severity Score: 6.25

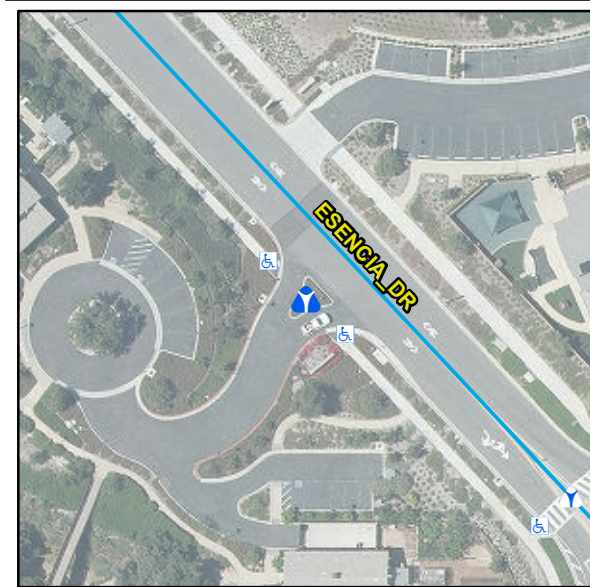
| Compliance | Description | Data | Compliance | Description | Data |
|---|---|---|---|---|---|
| No | Refuge 1 Width (In) | 58 | Yes | Gutter 1 Lip Ht (In) | 0 |
| No | Refuge 2 Width (In) | 58 | Yes | Gutter 2 Lip Ht (In) | 0 |

Possible Solutions:  
**Remove & Replace Entire Refuge.**

OC Std/PROW:  
**R302.3.1, STD 1115**

Total Cost: \$ **5000**
