# Access Compliance Report Public Rights-of-Way (Island Curb Cuts)

| Main Street: O_NEILL_DR | | Cross Street: CROWN_VALLEY_PKWY | | Location: | SW |
| ADA ID: CCRK211102122241 | Curb Cut Type: IslandRefuge3 | Initial Pass/Fail: Fail | Overall Compliance: No | Severity Score: | 40 |

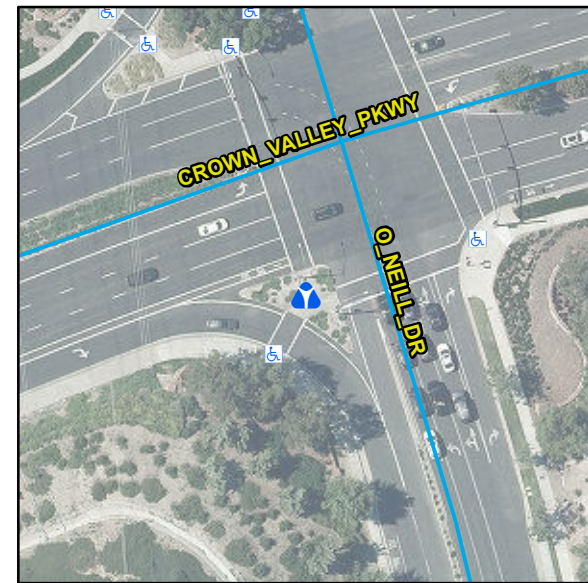
| Compliance | Description | Data | Compliance | Description | Data |
|---|---|---|---|---|---|
| No | Refuge 2 Cross Slope (%) | 6.2 | N/A | Gutter 2 Cross Slope (%) | N/A |

Possible Solutions:

**Remove & Replace Entire Refuge. Utility Present.**

**R302.6, STD 1115**

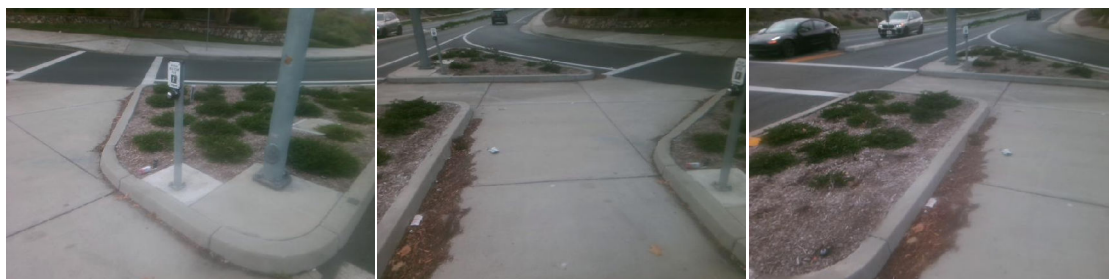
| Compliance | Description | Data | Compliance | Description | Data |
|---|---|---|---|---|---|
| Yes | Obstructions Present? | No | N/A | Utilities Present? | Yes |
| | Obstruction Dimensions | N/A | | Traffic Signal Pole, Push Button | |
