# Access Compliance Report Public Rights-of-Way (Island Curb Cuts)

| Main Street: O_NEILL_DR | | Cross Street: DORRANCE_DR | | Location: | E |
| ADA ID: CCRK211102125820 | Curb Cut Type: MedianRefuge2 | Initial Pass/Fail: Pass | Overall Compliance: No | Severity Score: | 15 |

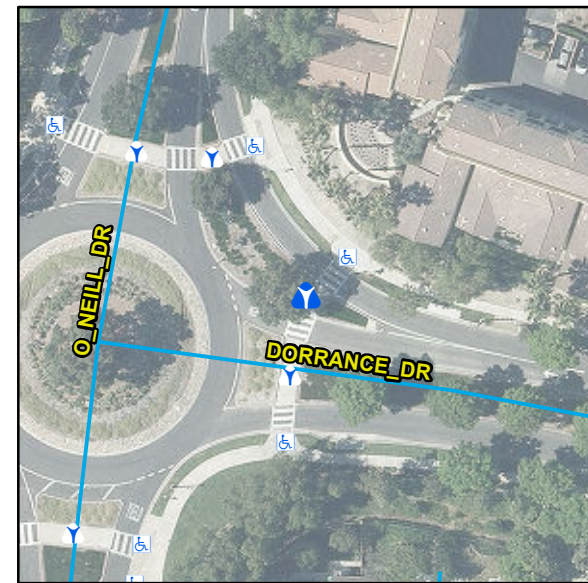
| Compliance | Description | Data | Compliance | Description | Data |
|---|---|---|---|---|---|
| N/A | Painted Cross Walk 1 | Yes | No | DWS 1 Provided | No |
| N/A | Painted Cross Walk 2 | Yes | No | DWS 2 Provided | No |
| Yes | Overall Surface Condition: Acceptable | | | | |

Install Detectable Warning System.
