# Access Compliance Report Public Rights-of-Way (Island Curb Cuts)

| Main Street: O_NEILL_DR | | Cross Street: O_NEILL_DR | | Location: | W |
| ADA ID: CCRK211102131856 | Curb Cut Type: MedianRefuge2 | Initial Pass/Fail: Pass | Overall Compliance: No | Severity Score: | 15 |

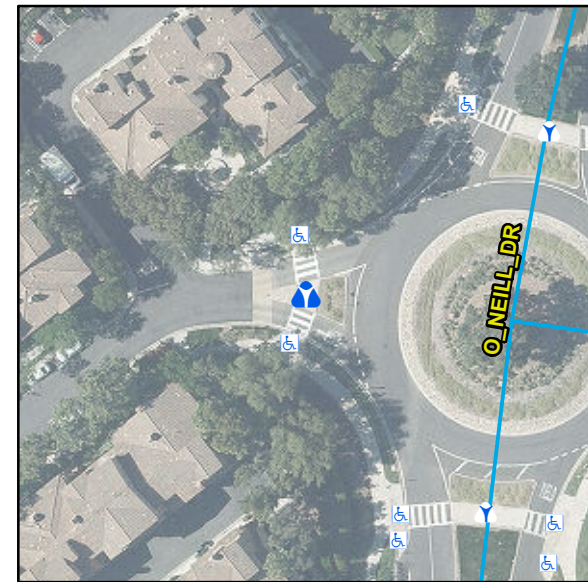
| Compliance | Description | Data | Compliance | Description | Data |
|---|---|---|---|---|---|
| Yes | Refuge 1 Cross Slope (%) | 4.5 | No | Gutter 1 Cross Slope (%) | 4.3 |
| N/A | Painted Cross Walk 1 | Yes | No | DWS 1 Provided | No |
| Yes | Refuge 2 Cross Slope (%) | 2.7 | No | Gutter 2 Cross Slope (%) | 3.3 |
| N/A | Painted Cross Walk 2 | Yes | No | DWS 2 Provided | No |

Possible Solutions:  
**Install Detectable Warning System. Remove & Replace Gutter.**

OC Std/PROW:  
**R305, R304.5.3, STD 1115**
