# Access Compliance Report Public Rights-of-Way (Island Curb Cuts)

| Main Street: O_NEILL_DR | | Cross Street: O_NEILL_DR | | Location: | S |
| ADA ID: CCRK211103151937 | Curb Cut Type: MedianRefuge2 | Initial Pass/Fail: Pass | Overall Compliance: No | Severity Score: | 15 |

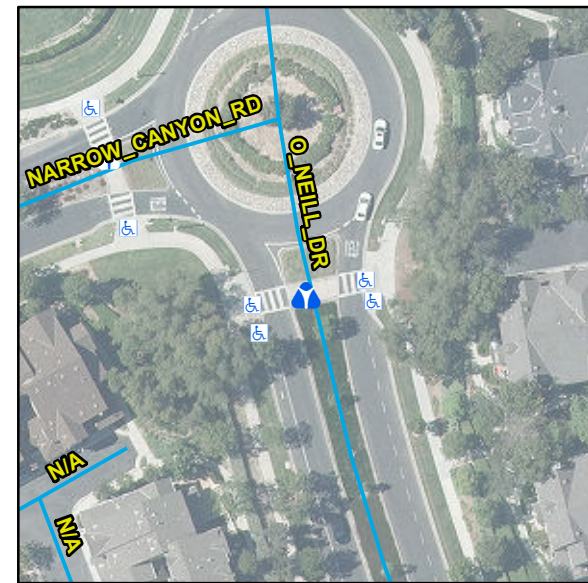
| Compliance | Description | Data | Compliance | Description | Data |
|---|---|---|---|---|---|
| Yes | Refuge 1 Cross Slope (%) | 4.3 | No | Gutter 1 Cross Slope (%) | 2.6 |
| N/A | Painted Cross Walk 1 | Yes | No | DWS 1 Provided | No |
| Yes | Refuge 2 Cross Slope (%) | 4.3 | No | Gutter 2 Cross Slope (%) | 4.6 |
| N/A | Painted Cross Walk 2 | Yes | No | DWS 2 Provided | No |

Install Detectable Warning System. Remove & Replace Gutter.
