Access Compliance Report Public Rights-of-Way (Island Curb Cuts)

Main Street: O NEILL DR Cross Street:O_NEILL_DR Location: Ν ADA ID: CCRK211103153226 Curb Cut Type: MedianRefuge2 **Initial Pass/Fail: Pass Overall Compliance: No Severity Score:** 15

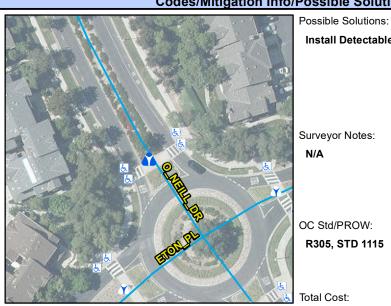
Field Measurements/Component Compliance									
1	Compliance Description		Data	Compliance Description		Data			
	Yes	Refuge 1 Length (In)	118	Yes	Guttter 1 Ponding	No			
	Yes	Refuge 1 Width (In)	96	Yes	Gutter 1 Lip Ht (In)	0			
	Yes	Refuge 1 Slope (%)	0.3	Yes	Gutter 1 Slope (%)	0.7			
	Yes	Refuge 1 Cross Slope (%)	0.6	Yes	Gutter 1 Cross Slope (%)	0.2			
	N/A	Painted Cross Walk 1	Yes	No	DWS 1 Provided	No			
		Cross Walk 1 Direction	E	N/A	DWS 1 Contrast	N/A			
		Cross Walk 1 Width (In)	144	N/A	DWS 1 Length (In)	N/A			
	Yes	Refuge Inside Cross Walk 1	Yes	N/A	DWS 1 Full Width	N/A			
		Road 1 Slope (%)	3.9	N/A	DWS 1 Offset (In)	N/A			
		Road 1 Cross Slope (%)	0.1			N/A			
	Yes	Refuge 2 Length (In)	122	Yes	Guttter 2 Ponding	No			
	Yes	Refuge 2 Width (In)	96	Yes	Gutter 2 Lip Ht (In)	0			
	Yes	Refuge 2 Slope (%)	0.3	Yes	Gutter 2 Slope (%)	4			
	Yes	Refuge 2 Cross Slope (%)	0.9	Yes	Gutter 2 Cross Slope (%)	2.1

,	N/A	Painted Cross Walk 2	Yes	No	DWS 2 Provided	No			
		Cross Walk 2 Direction	w	N/A	DWS 2 Contrast	N/A			
2		Cross Walk 2 Width (In)	144	N/A	DWS 2 Length (In)	N/A			
١	Yes	Refuge Inside Cross Walk 2	Yes	N/A	DWS 2 Full Width	N/A			
2		Road 2 Slope (%)	2.2	N/A	DWS 2 Offset (In)	N/A			
١		Road 2 Cross Slope (%)	1.2						
	Yes	Overall Surface Condition: Acce	ptable

Install Detectable Warning System.

R305, STD 1115
