# Access Compliance Report Public Rights-of-Way (Island Curb Cuts)

| ADA ID: CCRK211103162636 | Curb Cut Type: MedianRefuge2 | Initial Pass/Fail: Pass | Overall Compliance: No | Severity Score: | 15 |

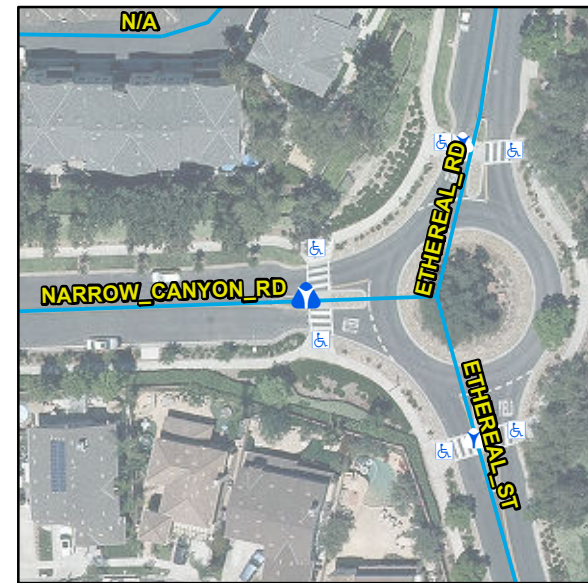
| Compliance | Description | Data | Compliance | Description | Data |
|---|---|---|---|---|---|
| Yes | Refuge 1 Cross Slope (%) | 1.9 | No | Gutter 1 Cross Slope (%) | 2.4 |
| N/A | Painted Cross Walk 1 | Yes | No | DWS 1 Provided | No |
| N/A | Painted Cross Walk 2 | Yes | No | DWS 2 Provided | No |

Install Detectable Warning System. Remove & Replace Gutter.
