# Access Compliance Report Public Rights-of-Way (Island Curb Cuts)

| Main Street: SIENNA_PKWY | | Cross Street: SIENNA_PKWY | | Location: | E |
| ADA ID: CCRK211104121935 | Curb Cut Type: MedianRefuge2 | Initial Pass/Fail: Pass | Overall Compliance: No | Severity Score: | 15 |

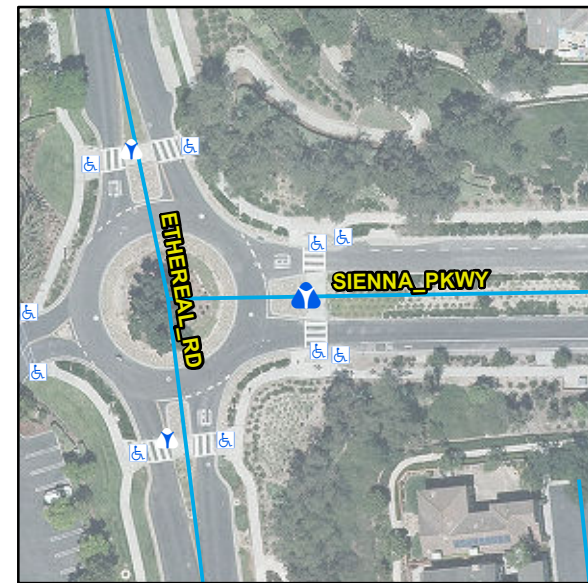
| Compliance | Description | Data | Compliance | Description | Data |
|---|---|---|---|---|---|
| N/A | Painted Cross Walk 1 | Yes | No | DWS 1 Provided | No |
| N/A | Painted Cross Walk 2 | Yes | No | DWS 2 Provided | No |

Possible Solutions:

Install Detectable Warning System.

OC Std/PROW:

R305, STD 1115

Total Cost: \$ 1200

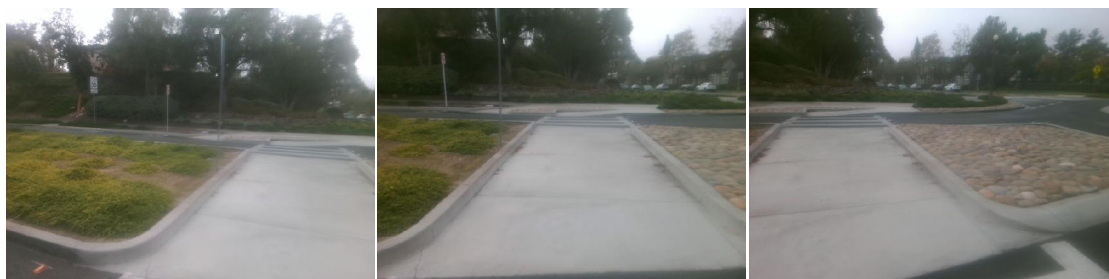
| Compliance | Description | Data | Compliance | Description | Data |
|---|---|---|---|---|---|
| Yes | Overall Surface Condition: Acceptable | | | | |
