# Access Compliance Report Public Rights-of-Way (Island Curb Cuts)

Main Street: SOL\_ST Cross Street: SOL\_ST Location: W

ADA ID: CCRK211104124436 Curb Cut Type: MedianRefuge2 Initial Pass/Fail: Pass Overall Compliance: No Severity Score: 15

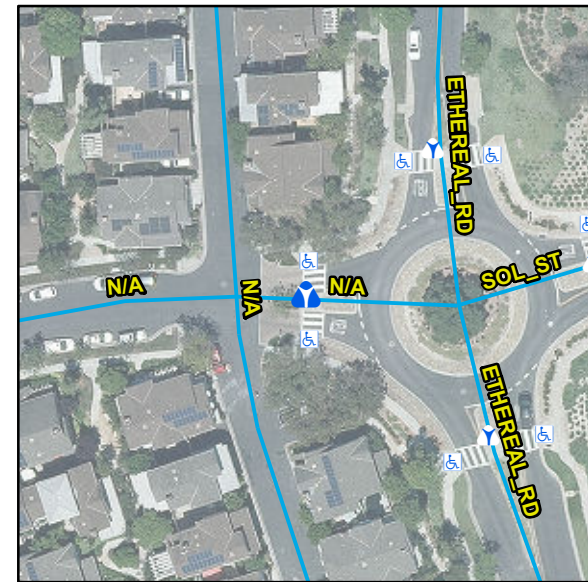
| Compliance | Description | Data | Compliance | Description | Data |
|---|---|---|---|---|---|
| N/A | Painted Cross Walk 1 | Yes | No | DWS 1 Provided | No |
| Yes | Refuge 2 Cross Slope (%) | 1.6 | No | Gutter 2 Cross Slope (%) | 3.2 |
| N/A | Painted Cross Walk 2 | Yes | No | DWS 2 Provided | No |

Possible Solutions:  
**Install Detectable Warning System. Remove & Replace Gutter.**

OC Std/PROW:  
**R305, R304.5.3, STD 1115**
