# Access Compliance Report Public Rights-of-Way (Island Curb Cuts)

| ADA ID: CCRK211104125320 | Curb Cut Type: MedianRefuge2 | Initial Pass/Fail: Pass | Overall Compliance: No | Severity Score: | 15 |

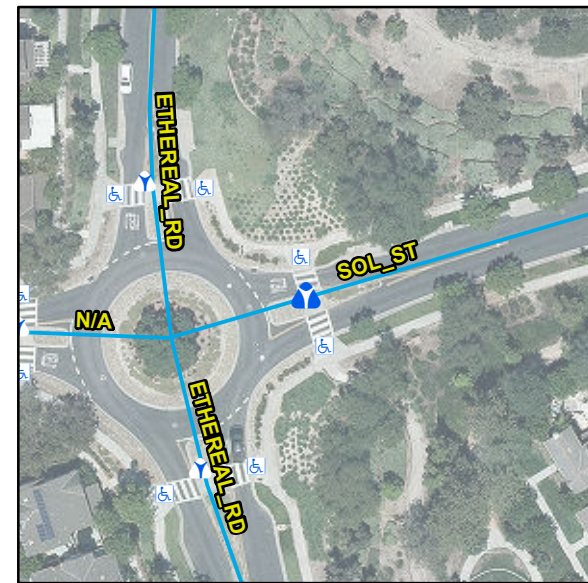
| Compliance | Description | Data | Compliance | Description | Data |
|---|---|---|---|---|---|
| Yes | Refuge 1 Cross Slope (%) | 3 | No | Gutter 1 Cross Slope (%) | 2.4 |
| N/A | Painted Cross Walk 1 | Yes | No | DWS 1 Provided | No |
| Yes | Refuge 2 Cross Slope (%) | 3.9 | No | Gutter 2 Cross Slope (%) | 3.8 |
| N/A | Painted Cross Walk 2 | Yes | No | DWS 2 Provided | No |

**Install Detectable Warning System. Remove & Replace Gutter.**

**R305, R304.5.3, STD 1115**

\$ 1704
