# Access Compliance Report Public Rights-of-Way (Island Curb Cuts)

| Main Street: SIENNA_PKWY | | Cross Street: SIENNA_PKWY | | Location: | N |
| ADA ID: CCRK211109115400 | Curb Cut Type: MedianRefuge2 | Initial Pass/Fail: Fail | Overall Compliance: No | Severity Score: | 15 |

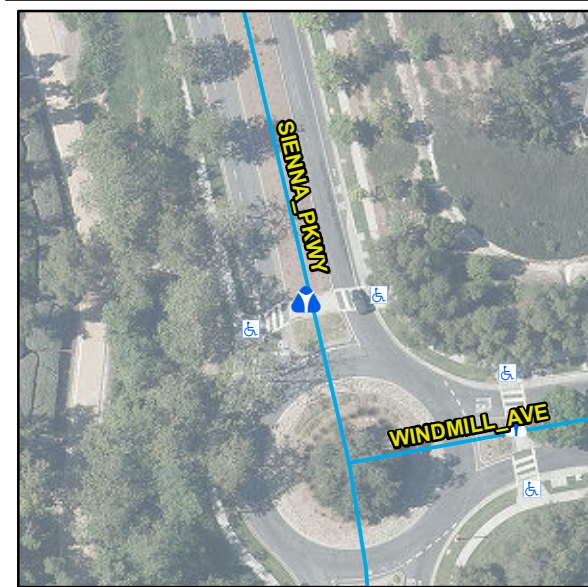
| Compliance | Description | Data | Compliance | Description | Data |
|---|---|---|---|---|---|
| No | Refuge 1 Cross Slope (%) | 5.5 | N/A | Gutter 1 Cross Slope (%) | N/A |
| No | Refuge 2 Cross Slope (%) | 5.1 | N/A | Gutter 2 Cross Slope (%) | N/A |

**Remove & Replace Entire Refuge.**

**R302.6, STD 1115**

**\$ 5000**
