# Access Compliance Report Public Rights-of-Way (Island Curb Cuts)

| Main Street: SIENNA_PKWY | | Cross Street: SIENNA_PKWY | | Location: | S |
| ADA ID: CCRK211109115815 | Curb Cut Type: MedianRefuge2 | Initial Pass/Fail: Fail | Overall Compliance: No | Severity Score: | 15 |

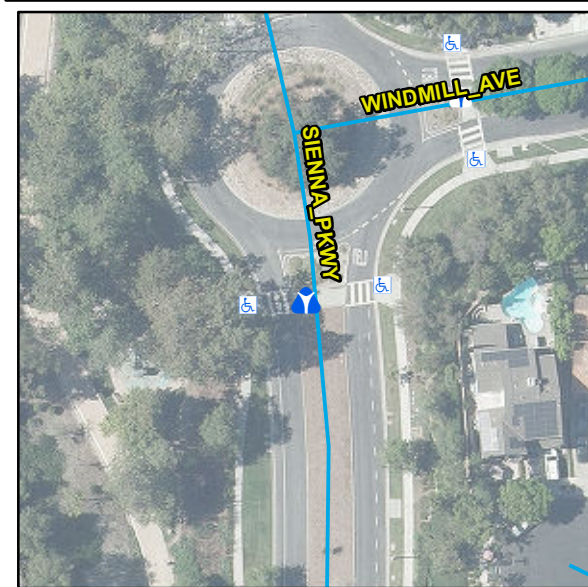
| Compliance | Description | Data | Compliance | Description | Data |
|---|---|---|---|---|---|
| No | Refuge 1 Cross Slope (%) | 6.3 | N/A | Gutter 1 Cross Slope (%) | N/A |
| No | Refuge 2 Cross Slope (%) | 5.8 | N/A | Gutter 2 Cross Slope (%) | N/A |

Possible Solutions:

Remove & Replace Entire Refuge.

R302.6, STD 1115

Total Cost: \$ 5000
