# Access Compliance Report Public Rights-of-Way (Island Curb Cuts)

| Main Street: SIENNA_PKWY | | Cross Street: SIENNA_PKWY | | Location: | NE |
| ADA ID: CCRK211109125148 | Curb Cut Type: MedianRefuge2 | Initial Pass/Fail: Pass | Overall Compliance: No | Severity Score: | 25 |

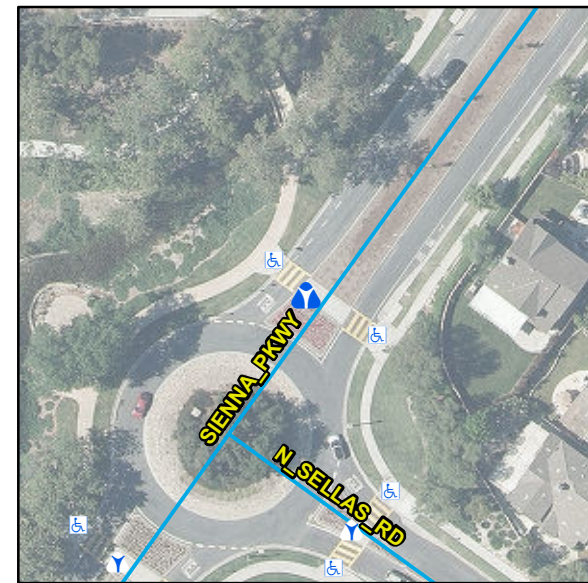
| Compliance | Description | Data | Compliance | Description | Data |
|---|---|---|---|---|---|
| Yes | Refuge 1 Slope (%) | 3.6 | No | Gutter 1 Slope (%) | 6.6 |
| N/A | Painted Cross Walk 1 | Yes | No | DWS 1 Provided | No |
| N/A | Painted Cross Walk 2 | Yes | No | DWS 2 Provided | No |

**Install Detectable Warning System. Remove & Replace Gutter.**

**R305, R304.5.4, STD 1115**

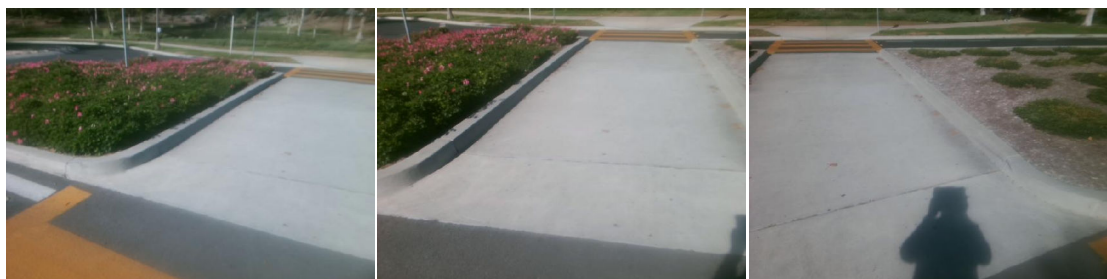
| Compliance | Description | Data | Compliance | Description | Data |
|---|---|---|---|---|---|
| Yes | Refuge 1 Length (In) | 168 | Yes | Guttter 1 Ponding | No |
