# Access Compliance Report Public Rights-of-Way (Island Curb Cuts)

| Main Street: SIENNA_PKWY | | Cross Street: SIENNA_PKWY | | Location: | SW |
| ADA ID: CCRK211109125813 | Curb Cut Type: MedianRefuge2 | Initial Pass/Fail: Pass | Overall Compliance: No | Severity Score: | 15 |

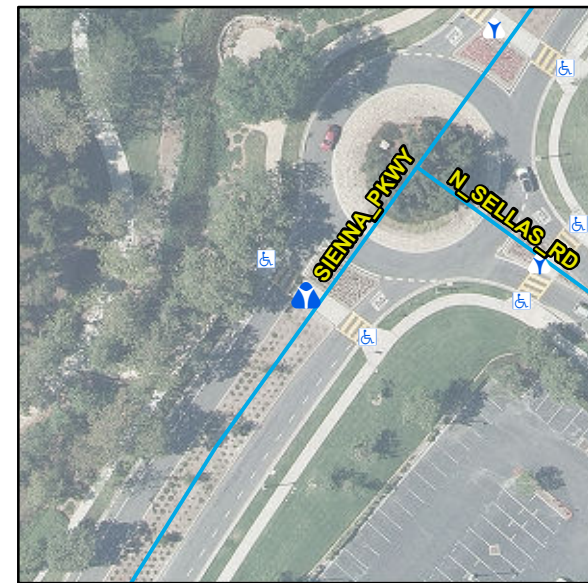
| Compliance | Description | Data | Compliance | Description | Data |
|---|---|---|---|---|---|
| N/A | Painted Cross Walk 1 | Yes | No | DWS 1 Provided | No |
| N/A | Painted Cross Walk 2 | Yes | No | DWS 2 Provided | No |

Possible Solutions:

Install Detectable Warning System.

R305, STD 1115

\$ 1200
